The West Salt Creek Landslide: A Catastrophic Rockslide and Rock/Debris Avalanche in Mesa County, Colorado

By Jonathan L. White, Matthew L. Morgan, and Karen A. Berry

Colorado Geological Survey
COLORADOSCHOOL**OF**MINES

2015

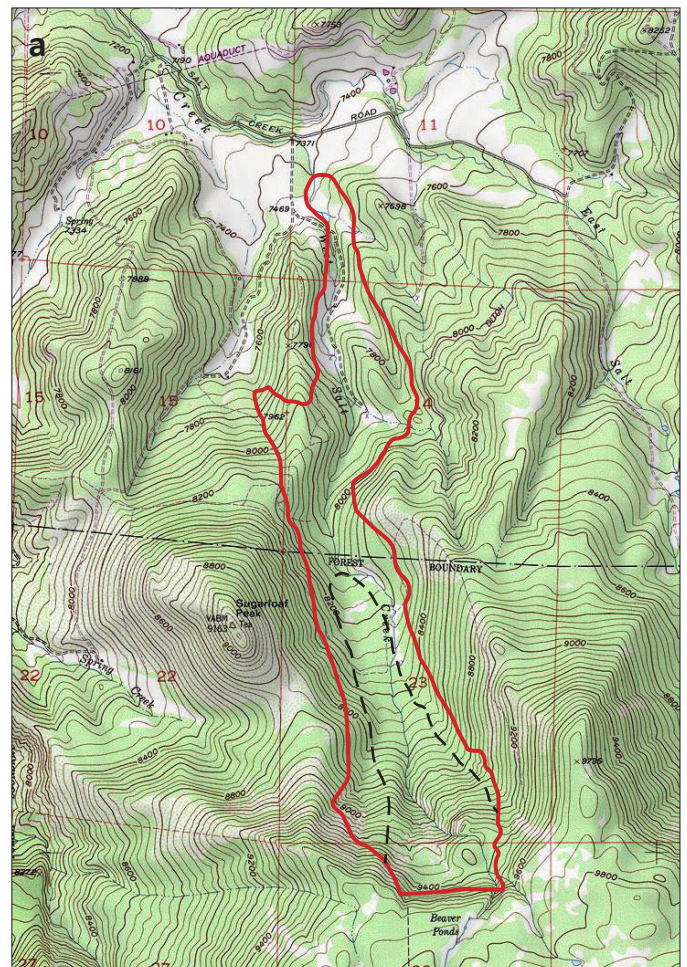
Figure 2. Outline of the WSCL is shown by solid red line. Section grid lines on USGS 1:24,000-scale topographic map are 1-mile square. Approximate boundary of pre-historic landslide is shown by black dashed line.

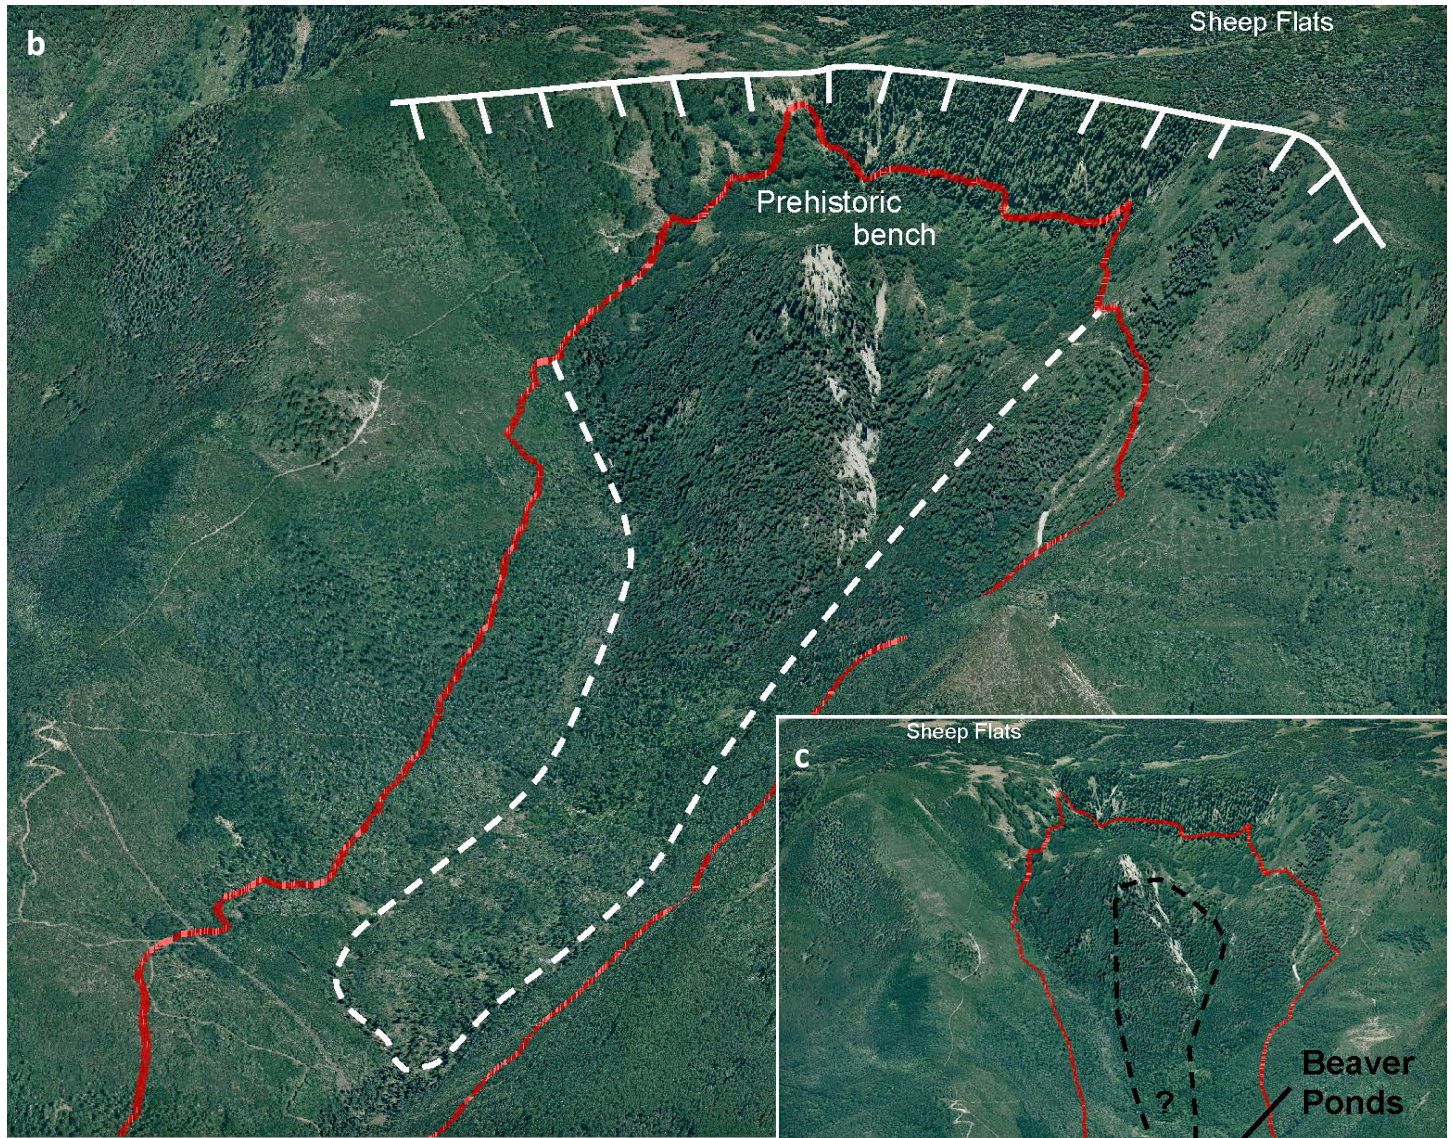
Figure 2(b). Approximate location of a prehistoric (Holocene) landslide (white dashed lines) and an ancient scarp (hachured solid white line) superimposed on a 2012 aerial photograph.

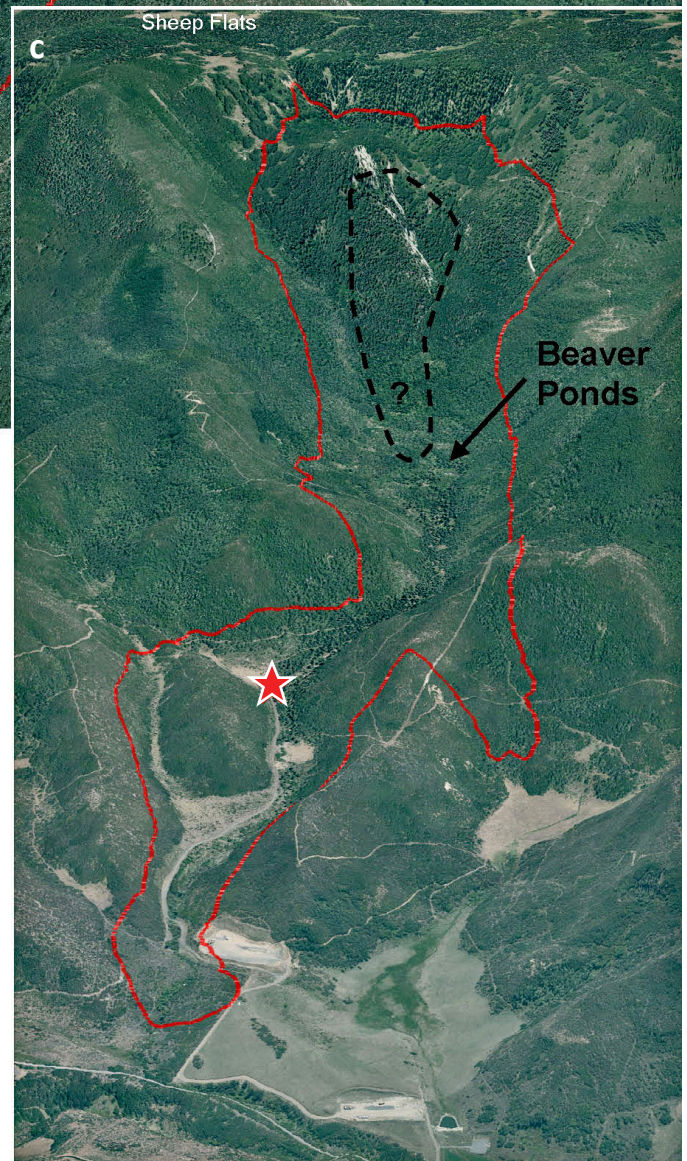
Figure 2(c). South-facing view of the WSCL with the approximate location of May 25th precursor landslides (black dashed line) that extended to the beaver ponds. The approximate extent of the precursor landslides were outlined by an eye-witness who saw them on morning of May 25th. Pre-event terrain models were created with ArcScene 10.2 using 2012, 9-in resolution color aerial photography from Mesa County GIS Department draped on a FEMA 4-m DEM. Red star is the assumed location of the missing pick-up truck at the end of the ranch road.

Following these precursor landslides, water in irrigation ditches originating from West Salt Creek stopped flowing. Mr. Hawkins stated that he went up the valley and heard trees snapping and toppling, possibly as a result of a mud/debris flow occurring high on the valley floor in the area of the “beaver ponds” (Figure 2c). In the afternoon, Wes Hawkins, Clancy Nichols, and Danny Nichols drove up the West Salt Creek Road to assess damages to the irrigation diversion structure and whether there was a landslide risk to Salt Creek Road (CR 60 ½ Rd.). The assumed last location of their pick-up truck is shown in Figure 2c where the West Salt Creek ranch road ends.

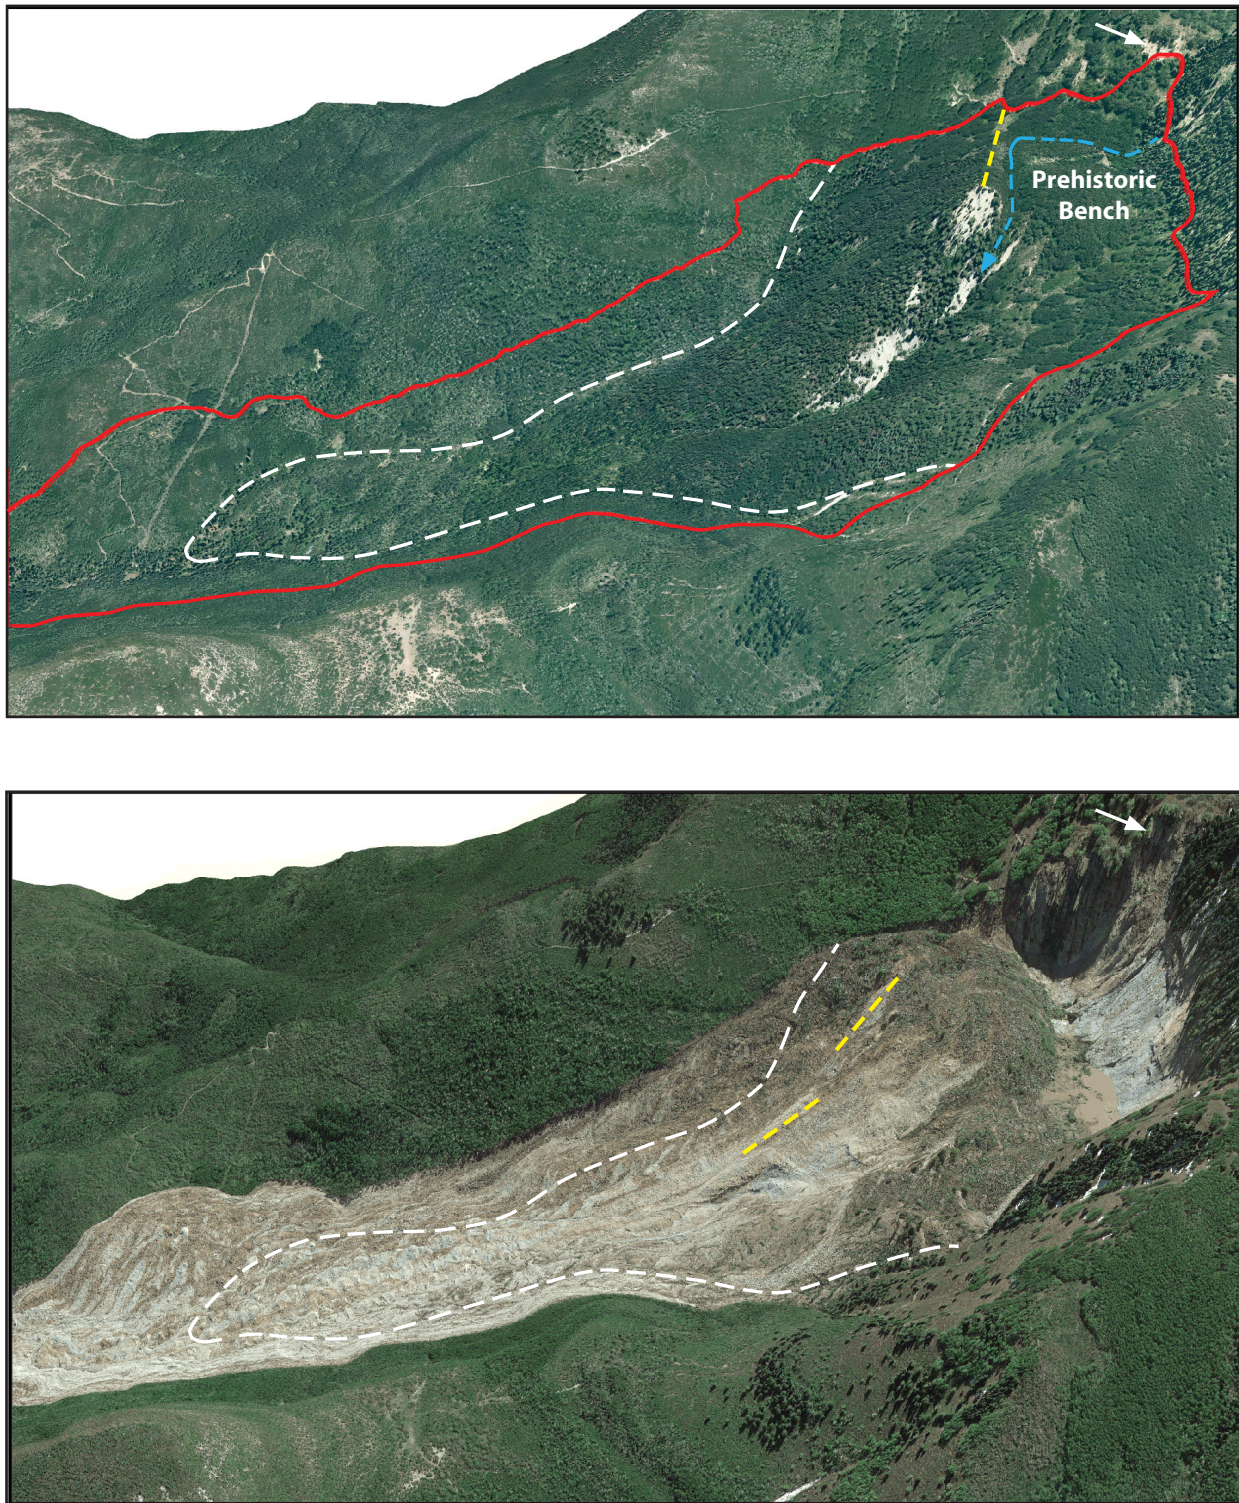
Figure 3. Pre- (top) and post-WSCSL (bottom) images created from draping high resolution aerial photography onto DEMs. Top uses 2009 NAIP image and FEMA 4-m DEM as elevation base. Red line shows the WSCSL extent. Dashed white line delineates runout of prehistoric landslide. Yellow dashed line shows prominent intermediate scarp block that has controlled the paleochannel of West Salt Creek (dashed blue line) that doglegs against it to follow a prominent shear zone on the paleobench before cascading down an earlier escarpment. Bottom image uses 1-m DEM from CGS LiDAR data and early post-WSCSL aerial photo from Google Earth™ where the sag pond (showing as muddy water) was small and still filling. Prehistoric landslide is shown by dashed white line. Yellow dashed lines mark steep scarps in block face that were likely avalanche detachment zones. White arrows show location of small 1984 landslide on both images.

The Upper Block is the remnant of the prehistoric landslide of the same area (Figure 3). On May 25th, 2014, the Upper Block rotationally slid down this pre-existing listric (concave upwards) surface of rupture related to the prehistoric landslide. The rotation and back tilt of the block disrupted the block surface into many fissured domains with varying declinations, typically between 12° and 15° toward the headscarp. Concurrently, the near vertical

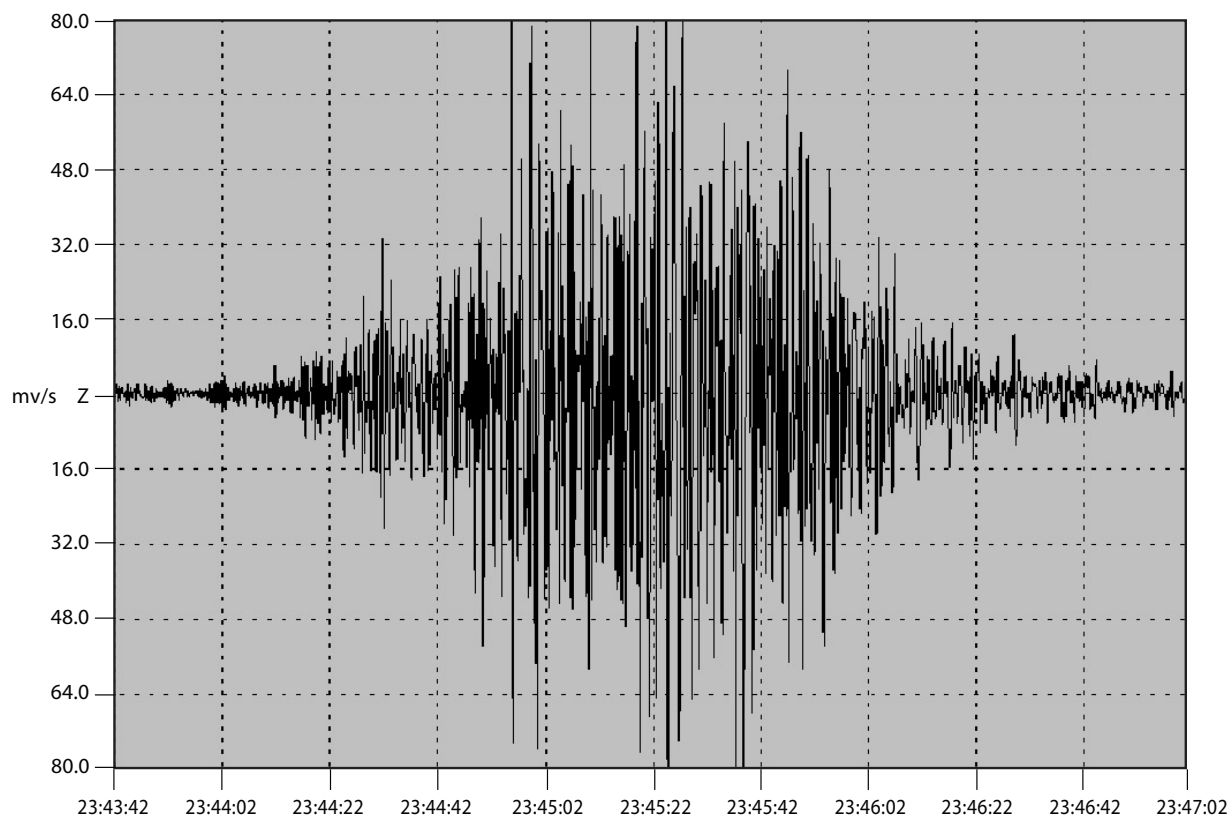
Figure 4. Colorado Mesa University Seismic Network seismogram of the WSCL event. Seismometer was 24.7 miles away at their Rapid Creek Station (courtesy of Dave Wolny, Colorado Mesa University). Note the spikes in the wave train that may indicate episodic failures of the rockmass.

In addition, peaks in the seismic wave train (Figure 4) may indicate larger rock mass failures that correspond to the discrete surge episodes. Of significant importance is the pocket of red-clay colluvium with abundant basalt rocks that occurs on the east flank of the valley above the Upper Block, and as disturbed prehistoric landslide deposits on the eastern side of the Upper Block bench in the original pre-May 25th landscape (see Figures 2, 3, and 6b). The first two surges were the result of high-velocity rock avalanches, while the last deposit occupies only the valley floor. This last surge was lower velocity and has morphological characteristics of a rocky earth flow.

3. Very large segments of mobilized rock mass, with a lateral velocity component, sheared off the face of the Upper Block along these high-angle shear zones. While speculative, the seismic waves (Figure 4) seem to indicate that there was a time-relative spacing of the failure of the rock mass segments and development of the cascade of rock avalanche debris surges over the 3-minute period. The crosscutting morphology of the rock avalanche deposits supports the theory of discrete avalanche surges.

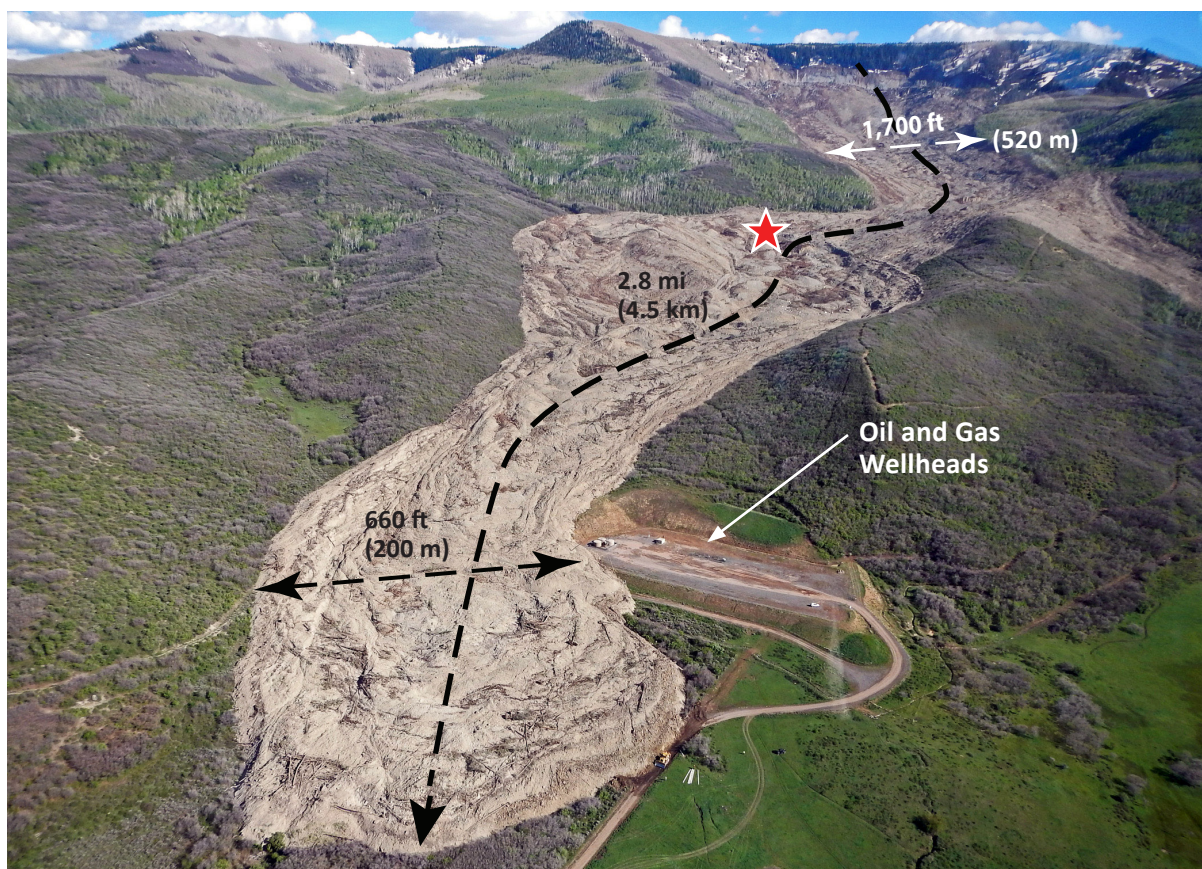
Figure 5. Oblique photo of the WSCL taken May 26th, 2014. The red star is the assumed truck location of the three men killed in the landslide. It is approximately located at the end of the West Salt Creek ranch road, which forks off at the front of the well pad.

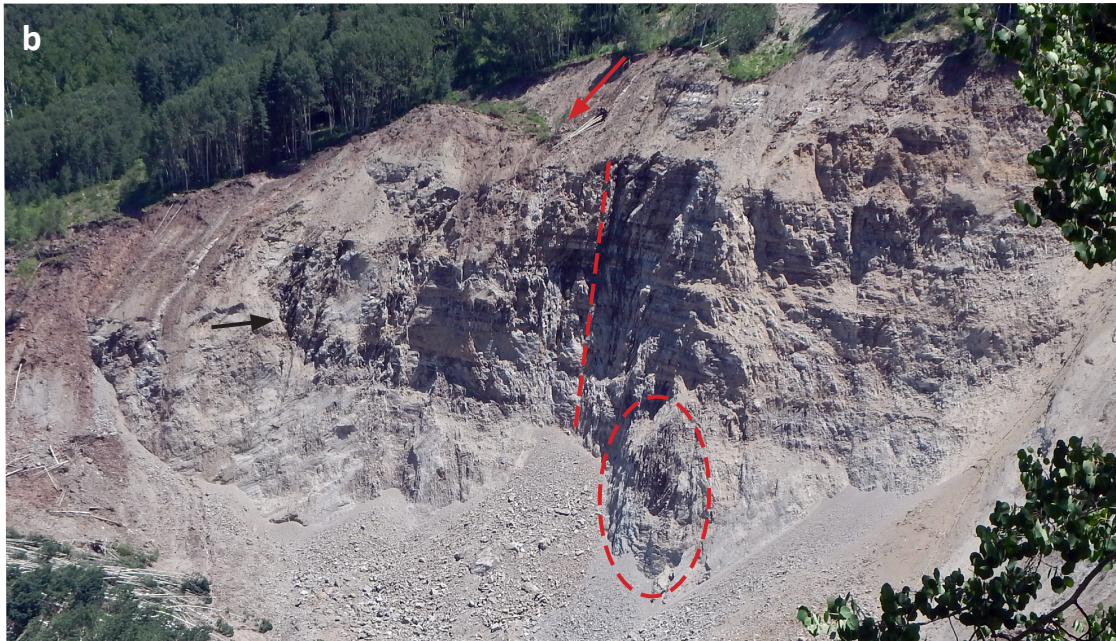
Figure 6(b). Photo of the east side scarp. Disturbed rockmass is the Green River Formation. Note sheared rock fabric and landslide displacement at side scarp shown by red arrow. Colluvial red soil is also seen in the scarp along left edge of photo. Red dashed line approximates major near-vertical shear zone. Dashed oval marks tightly spaced, near vertical shearing in rockmass.

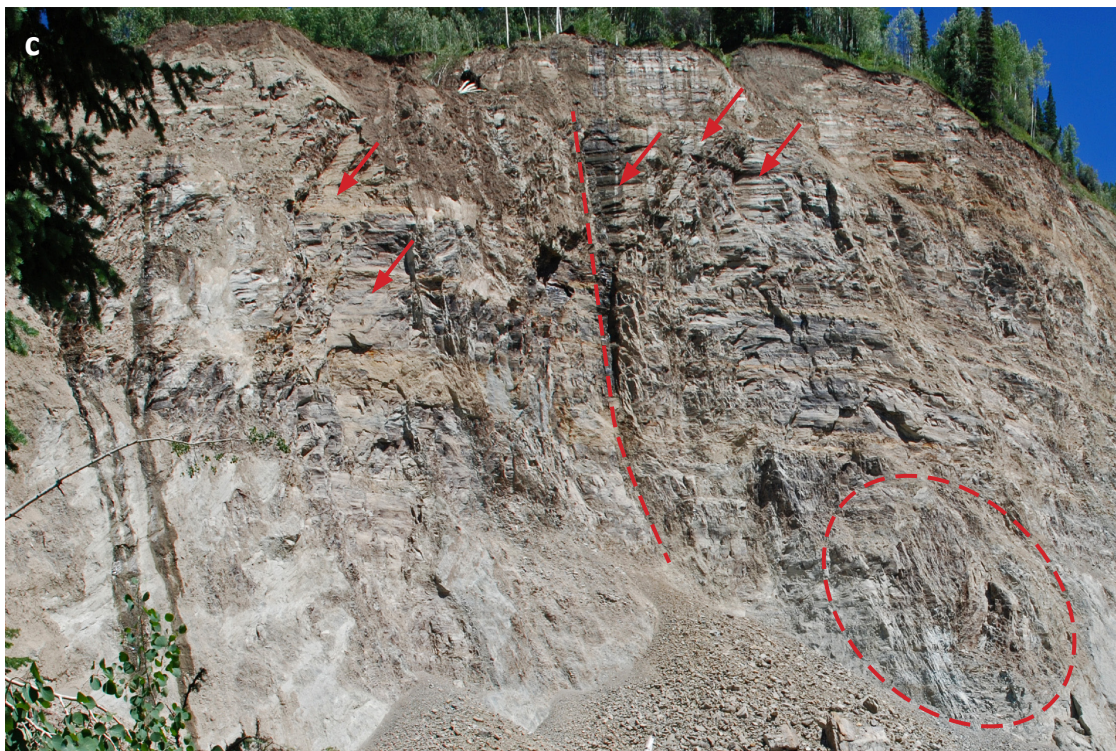
Figure 6(c). Photo is a close up of east side of headscarp (courtesy of Rex Cole, Colorado Mesa University). Note steep shear surfaces shown by arrows. Dashed red line and oval is in same location as shown in 6b. Seepage flow on rock face to left is occurring from another shear zone. The same location is shown by black arrow in 6b.

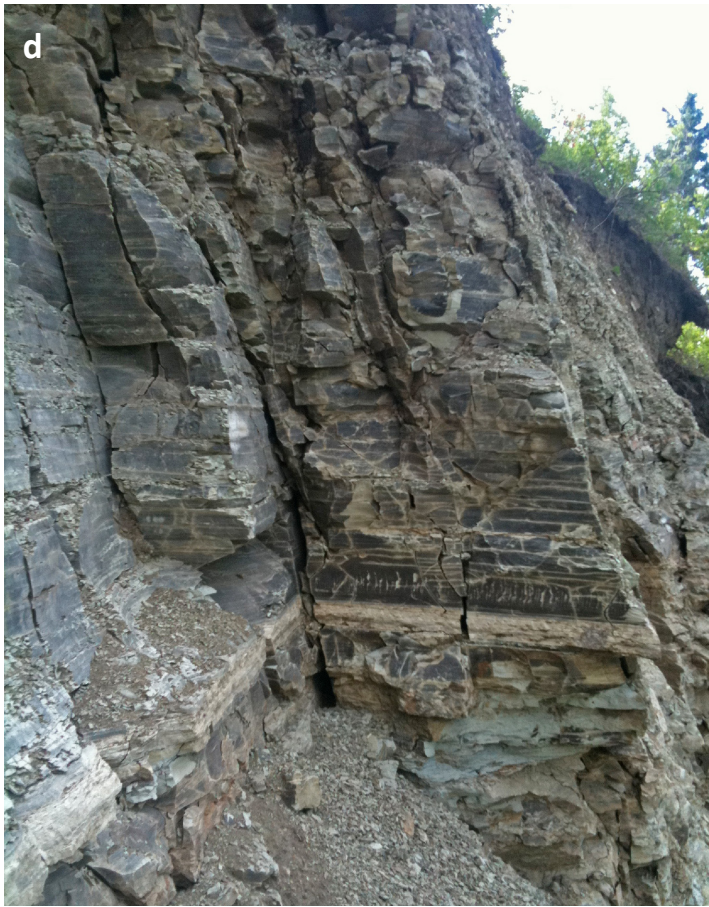
Figure 6(d). Exposed Green River Formation on west flank of scarp. Note blue-gray staining and degree of fracturing in the rockmass. Photos taken summer of 2014.

and highly fractured with prominent blue-gray stained surfaces (Figure 6d). Active seeps in the rock faces of the head scarp and flank scarps continued for several days after the landslide.

in outcrop near the headscarp (Figure 6d); while speculative, this range in clast size may be indicative of the fracture network and preferential gradation in the disaggregation of the rock mass. Accessory clasts types include rare sandstone and limestone, chert, and basalt boulders derived from alluvium, colluvium, and glacial till deposits that were originally deposited on the plateau above.

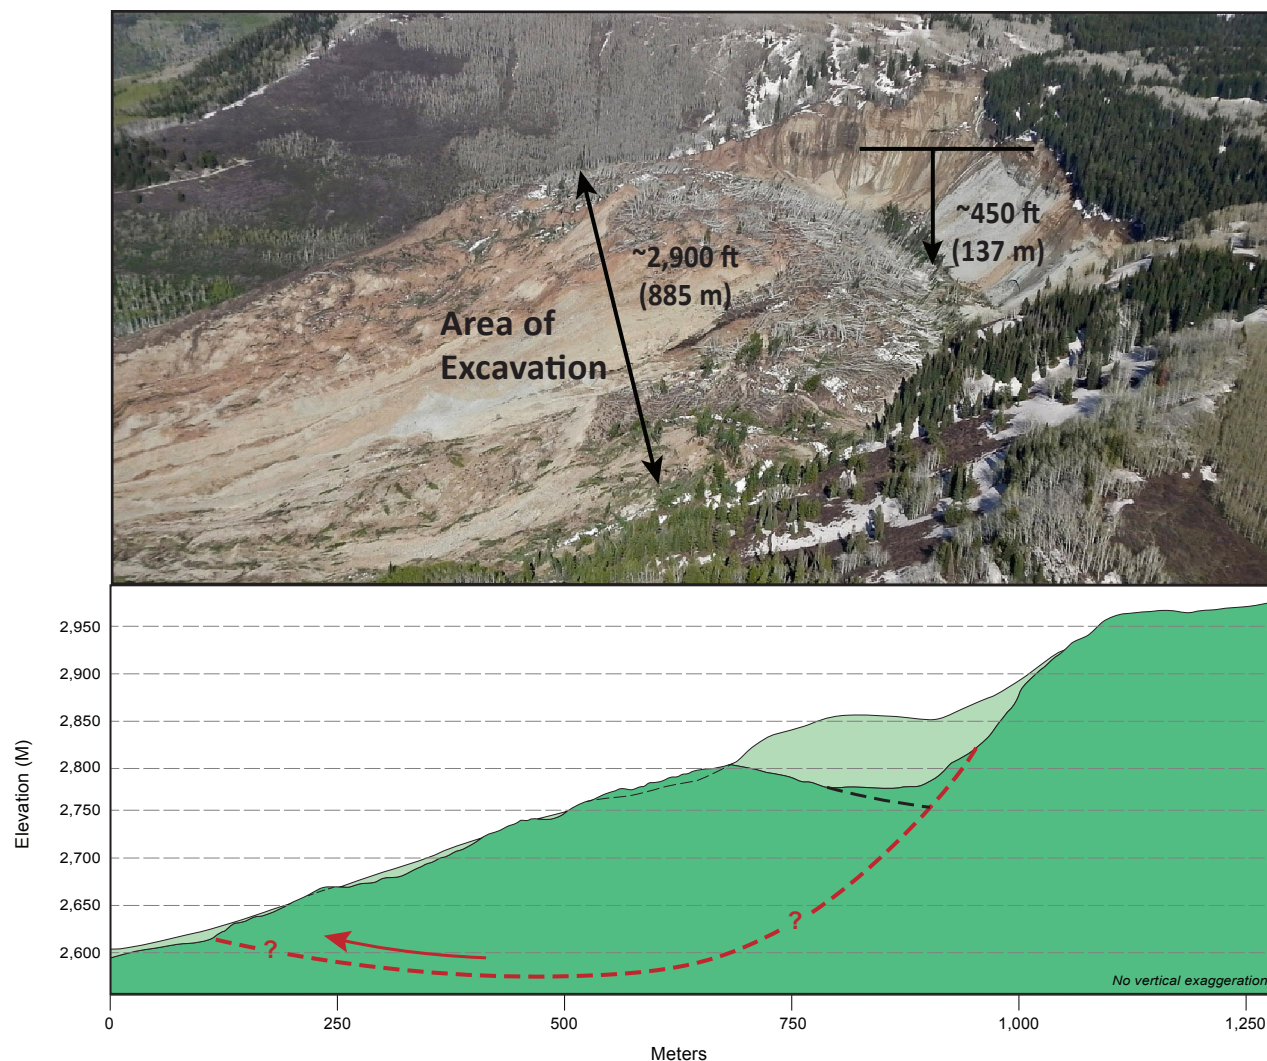
Figure 7. Photo at top is an oblique east-facing aerial photo of the Upper Block taken May 26th the day after the landslide before the sag pond began to fill. Lower image is a cross section at the center of the block at the approximate linear scale of the photo showing the assumed rotational failure surface as a dashed line. Dark green area is the post-failure surface after pond began to fill and material sloughed into depression from the scarp. Light green area is the pre-failure surface.

The large closed depression behind the Upper Block had a maximum depth of 110 ft (34 m) (**Figure 7**). The jolt and resultant ground disturbance from down dropping and back tilting, as the block slid down >450 vertical ft (137 m) along the scarp, caused extensive ground-surface ruptures, heaves, and subparallel fissures. Most of the trees were tilted or downed and thrown back towards the scarp face. Much of the broken ground on the eastern half of the block exposed reworked and transported reddish-orange colluvial/landslide soil with abundant Grand Mesa basalt boulders that were originally deposited along the east rim of the amphitheater (**Figure 8a**).

1. The disturbed rock mass was thrust out from the toe of the Upper Block along an assumed rotational slip plane shown in Figure 7.
2. The rock mass was composed of brittle, fractured, and thinly bedded shale and marlstone that was already disturbed by shearing and earlier landsliding. The original near-vertical joints and shears, now tilted by rotation of the Upper Block by both the prehistoric landslide and the WSCL, dip steeply (55°–70°) toward the valley below.

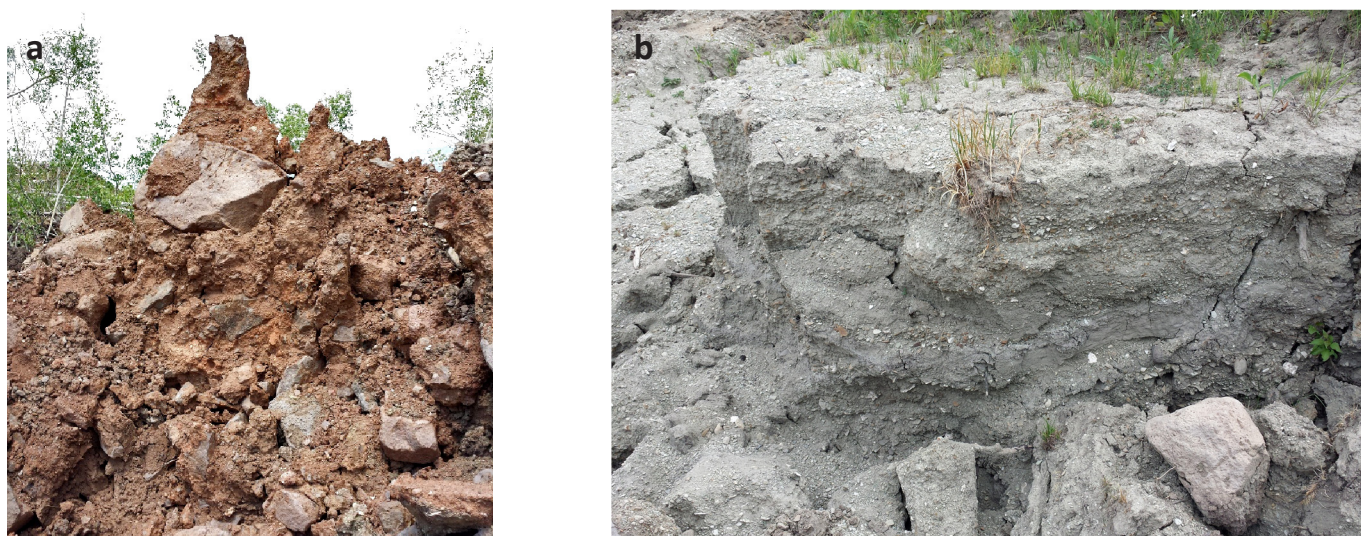
Figure 8. Upper Block sediments ruptured and heaved by May 2014 landslide movements. a) red colluvium with basalt clasts, b) Alluvium deposited on original Upper Block bench when prehistoric sag feature in-filled after failure in the recent geologic past. Photos taken summer of 2014. Photo locations are shown on Figure 9 map.

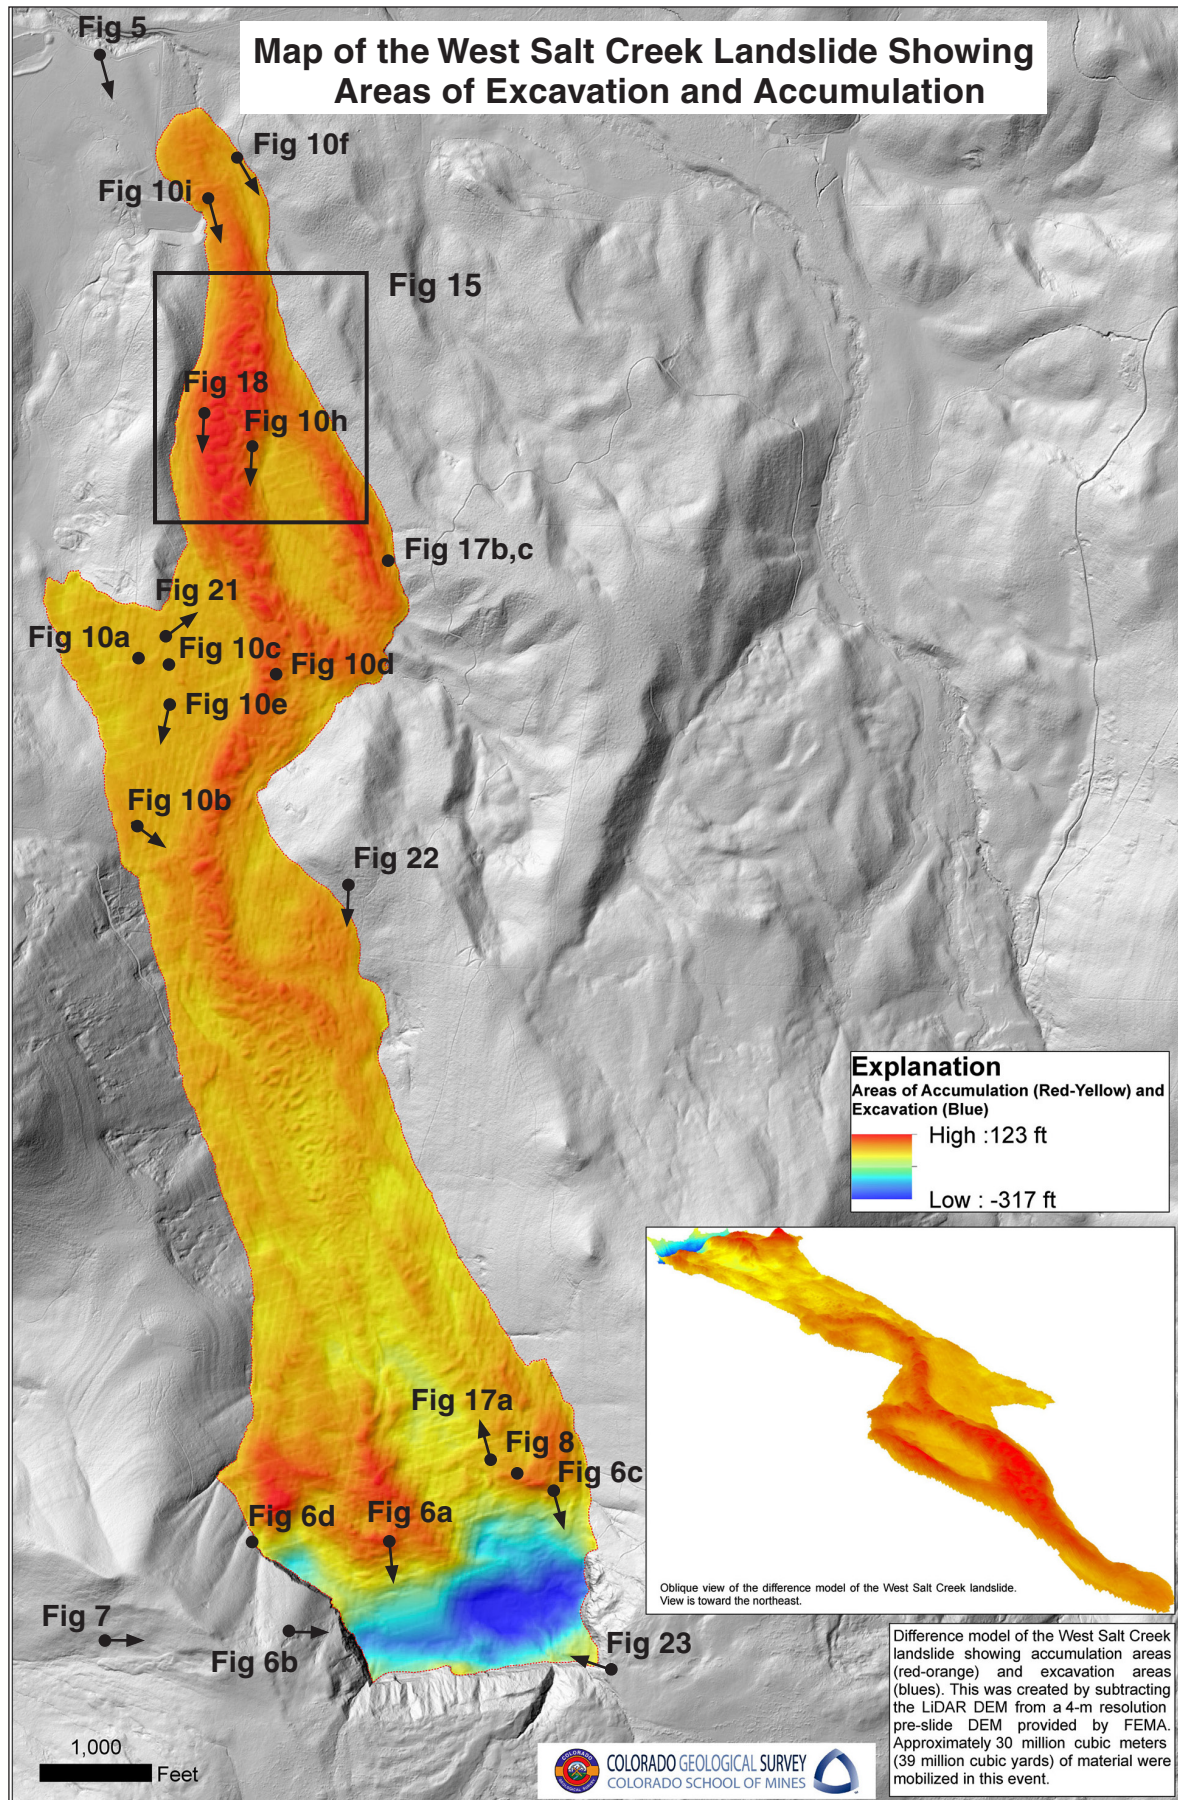
Figure 9. Material difference model. LiDAR hillshade is used as the basemap. Location of photo figures in this report are shown by points or view-direction arrows.

The extent, approximate thickness, and morphology of the rock avalanche is shown in **Figure 9**. The volume of rock avalanche debris that filled West Salt Creek valley, calculated from the base of the Upper Block is approximately 17 million yds³ (13 million m³) using comparative analytical tools in Global Mapper™ GIS software. The GIS analysis also indicates rock avalanche deposit thicknesses up to 123 ft (~38 m) along the thalweg of the original stream channel. This event was extremely rapid, with eyewitness accounts indicating the majority of the rock avalanche deposit was in place over two miles down the valley in a matter of minutes (Melvin “Slug” Hawkins, oral communication, 2014). Based on the seismic data shown in Figure 4, the rock avalanche occurred from a 3-minute sequence of failure and rotation of the Upper Block and episodic rock mass failures from the zone of evacuation along the front of the Upper Block as it rotated, fragmented, and large blocks slipped down the very steep shear surfaces. Initial pulses of disaggregated and pulverized rock and related soil and vegetal debris had the volume and velocity to overtop and spillover two ridges of the West Salt Creek valley where the creek thalweg curves. These ridgelines, shown on the geologic map in Plate 1, are referred to as the West Ridge and the East Ridge.

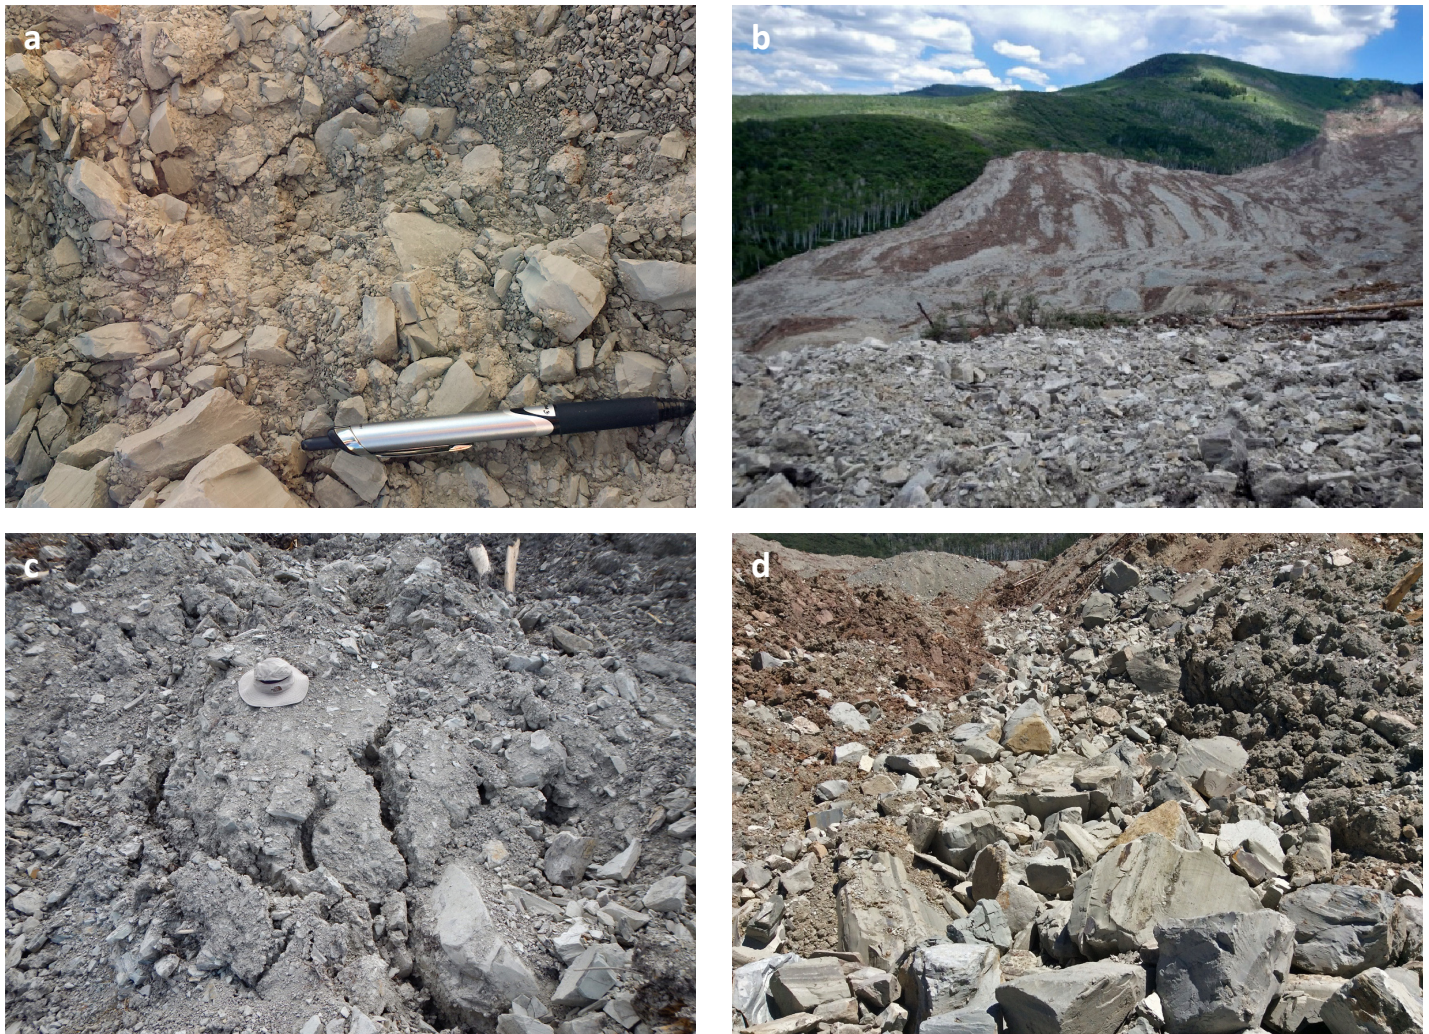
Figure 10. Rock avalanche debris locations: (a) typical matrix of avalanche deposit. Note pen for scale; (b) typical rocky debris field on west ridgeline. Note red-soil zebra-stripes related to spread of surficial soils on east flank; (c) subsidence fissures in deposit; (d) bouldery segregation within late-surge hummocky rock-debris flow; (e) debris on rise of west ridge spill over, red circle encloses person for scale; (f) east edge of debris field near toe. Photos taken summer of 2014. Photo locations are shown on Figure 9 map.

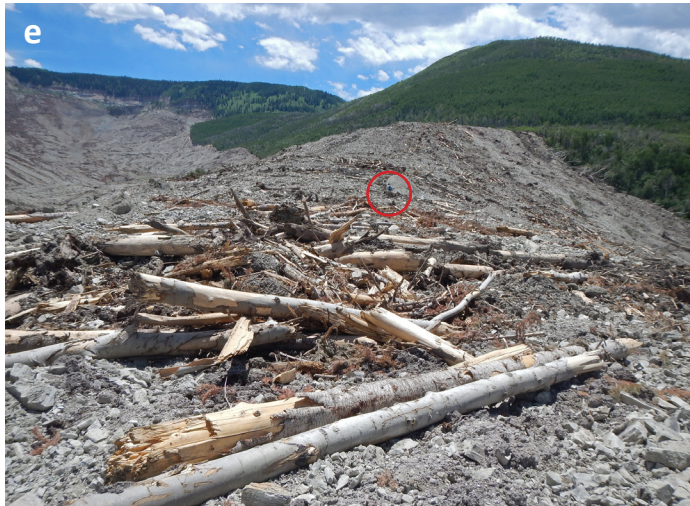
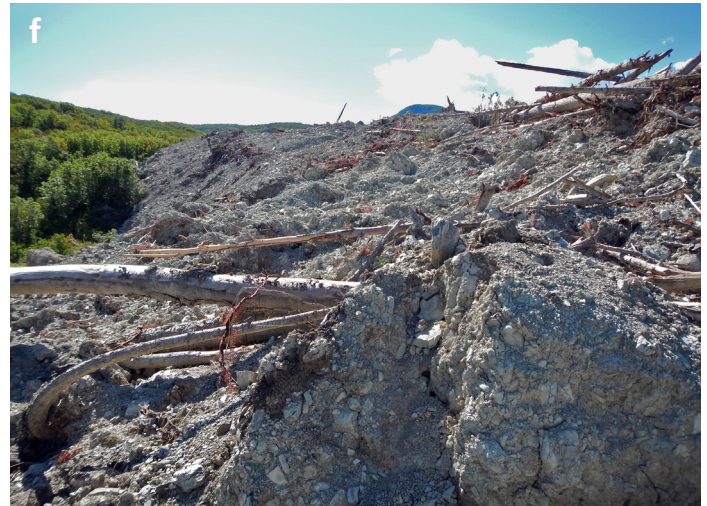
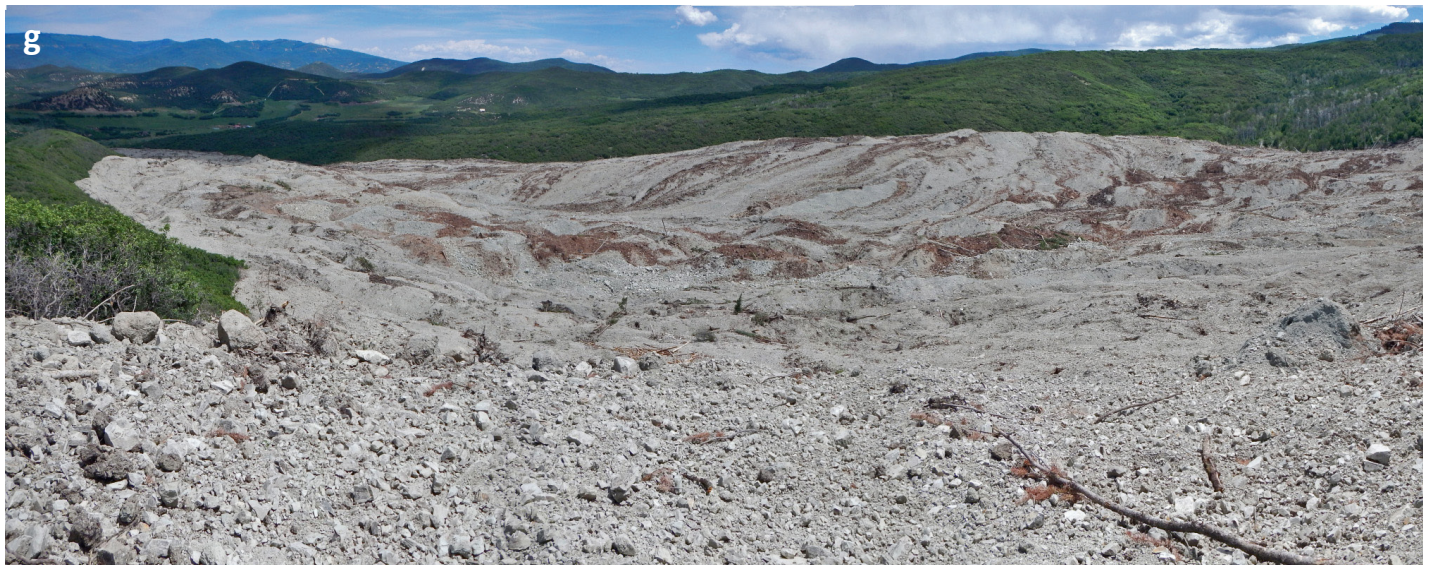
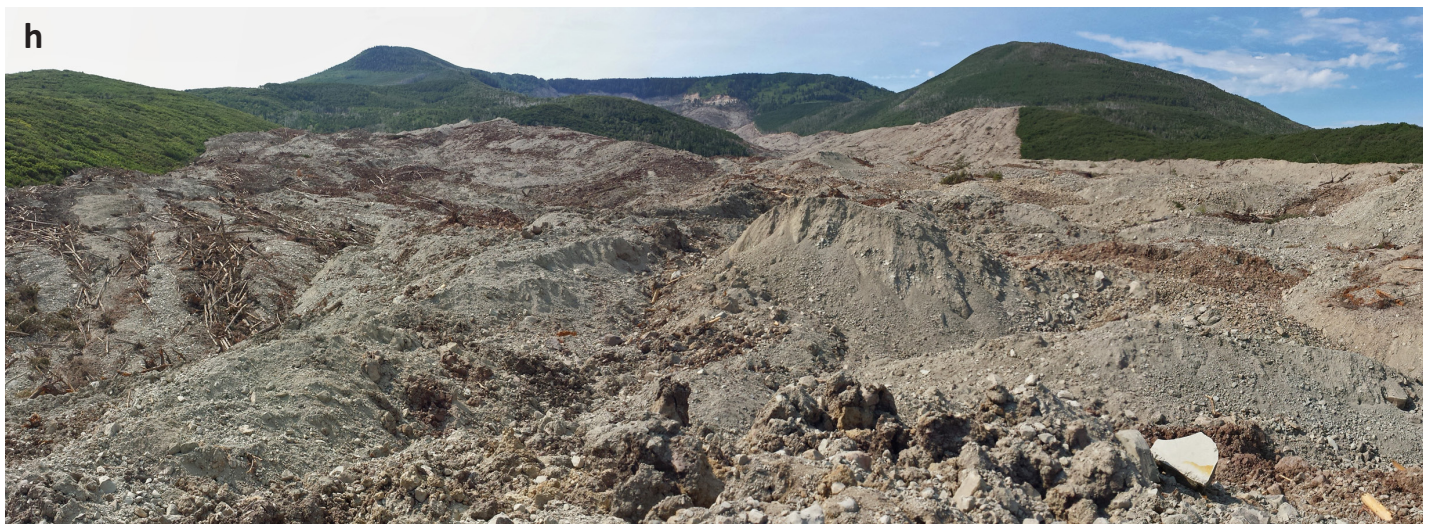
Figure 10 (con't). Rock avalanche debris locations: (g) debris field, photo taken from West Ridge towards East Ridge. Late surge hummocky rock-debris flow can be seen in center; (h) view up slope from flank of East Ridge, note spill over at West Ridge, dog-leg in East Elk Creek thalweg, and late surge hummocky rock-debris flow on floor; (i) con't on page 16.

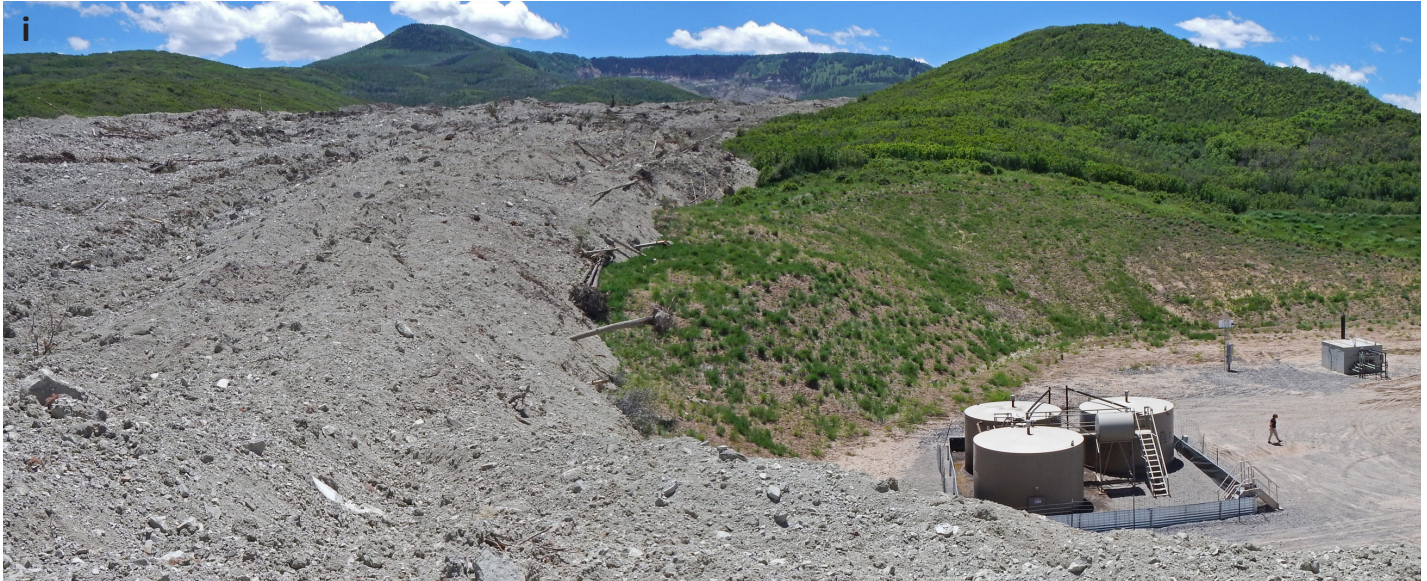
Figure 10 (i) View up slope in toe area, note proximity to oil and gas well infrastructure.

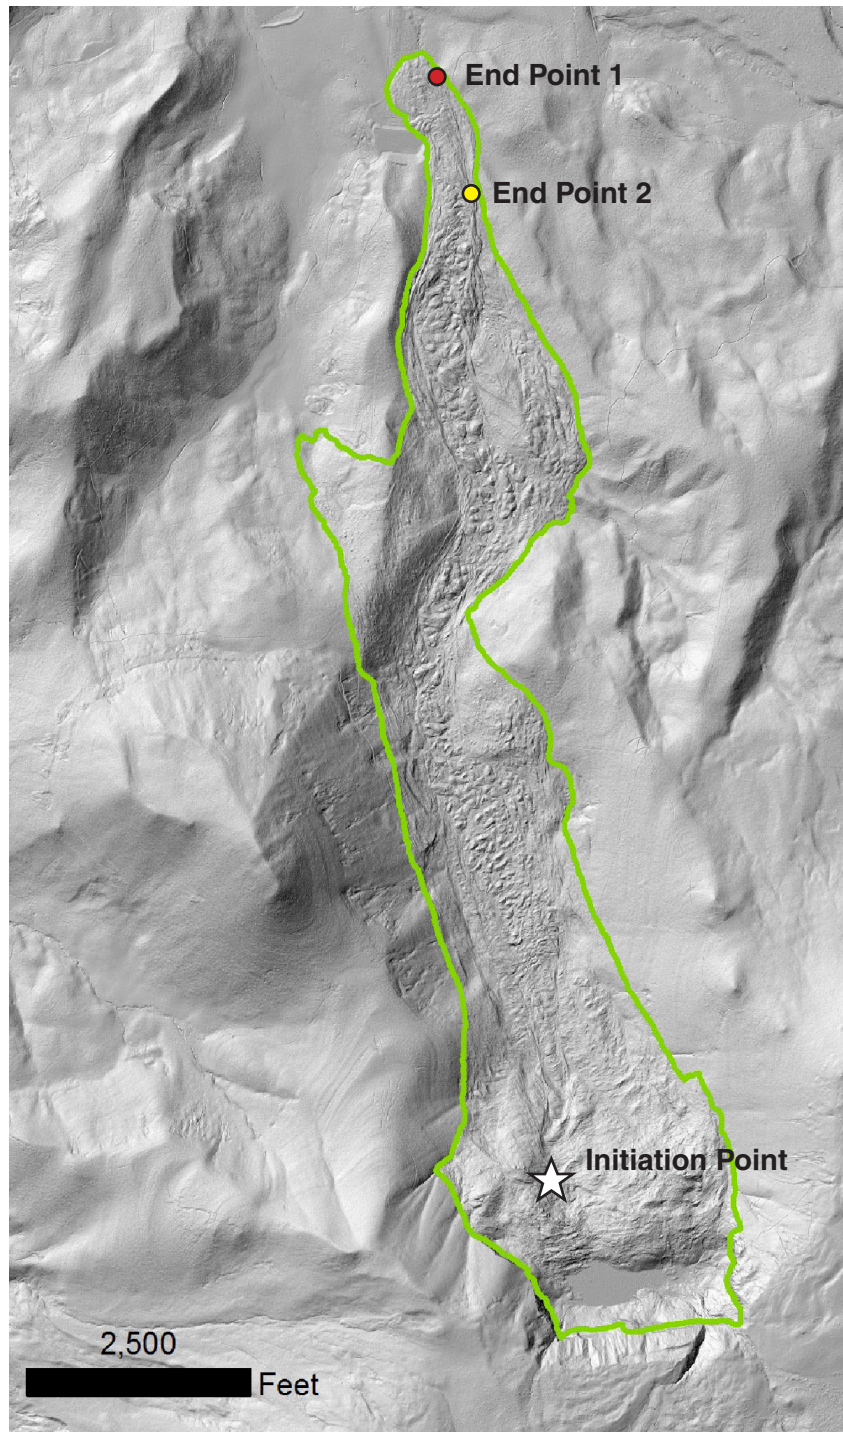
Figure 11. Hillshade of the WSCL with data points used in simplified estimated velocity calculations. The “Initiation Point” (white star) for the rock avalanche deposits is at the approximate location of a scarp consisting of more intact bedrock relative to the majority of brecciated debris below the scarp. End Point 1 (red circle) corresponds to furthest mapped deposit of a gray polymict breccia (part of early Surge) and End Point 2 (yellow circle) is where early surge may have impacted the valley side as it came off the spillover and where the red basalt-rich deposits end.

The event as recorded on the seismograph, began at 17:43:45 with a duration of approximately 3 minutes. A rudimentary velocity calculation using $v=d/t$ where d is distance and t is time, assuming the shortest distance of 2.12 mi (3.41 km), yields
