The West Salt Creek Landslide: A Catastrophic Rockslide and Rock/Debris Avalanche in Mesa County, Colorado

By Jonathan L. White, Matthew L. Morgan, and Karen A. Berry

Colorado Geological Survey
COLORADOSCHOOL**OF**MINES

2015

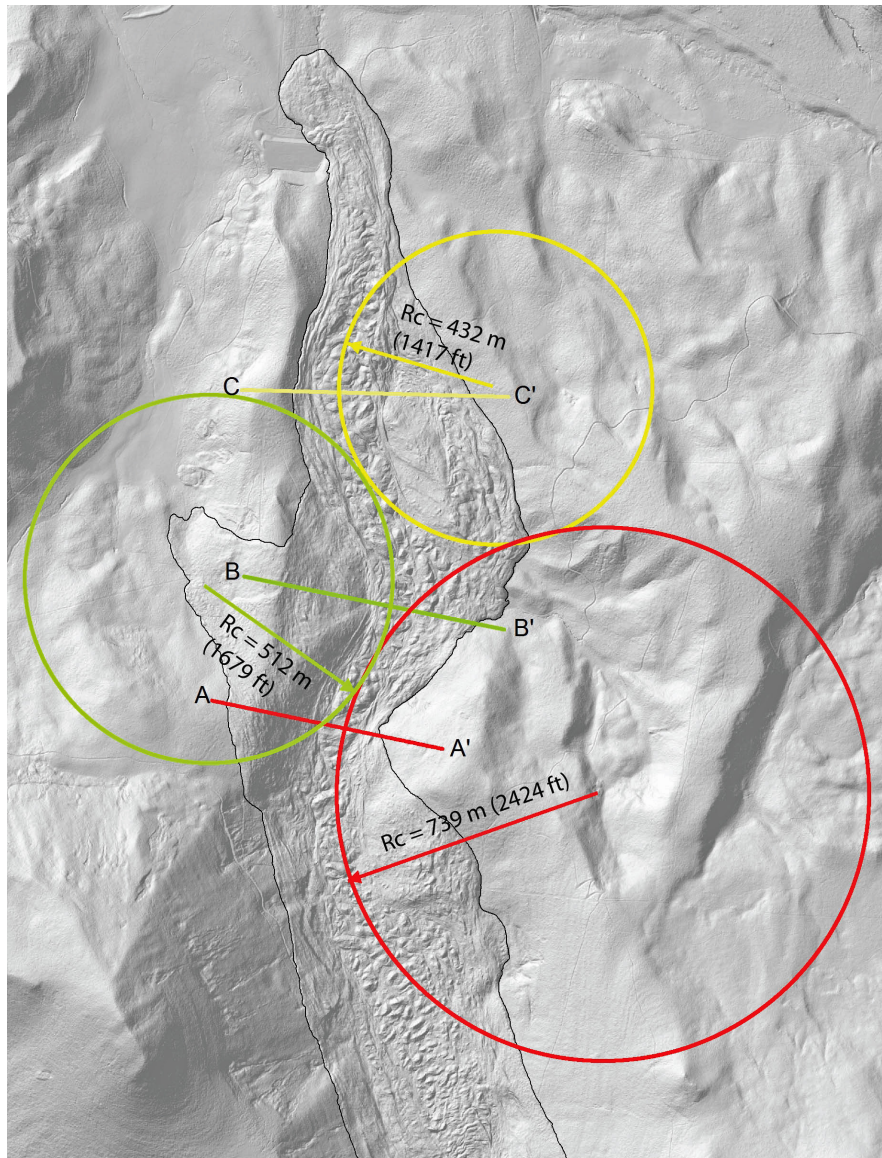
Figure 12. Hillshaded LiDAR DEM of the area of the WSCL analyzed for velocity estimates. “Best-fit” circles were used to determine the radius of curvature (R_c) for channel beds. Alignment of cross-section profiles are labeled A-A', B-B', and C-C'.

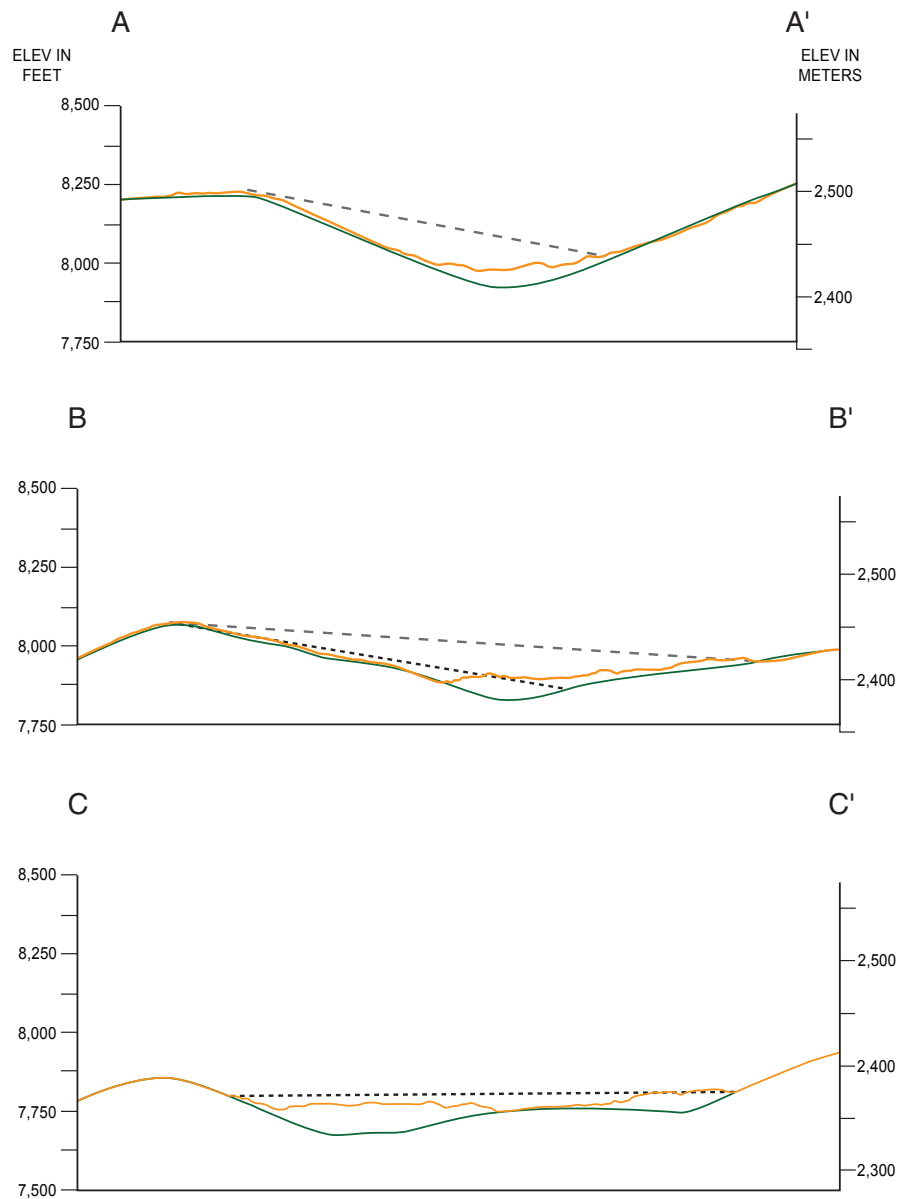
Figure 13. Cross-section profiles created from pre- and post-event DEMs. Location of the cross-section alignments are shown on Figure 12. The original topography is indicated by the green line and the landslide debris topography is shown by the red line. Dotted black line is the banking angle as determined from trim lines of probable correlative deposits. Two banking angles were proposed for cross section B-B'. The dashed black line is a very conservative estimate from hilltop to the widest extent of deposits. The dotted line was determined from the angle of the first surmounted hill and the approximate location where a parallel line would have intersected the valley below.

The sections show the comparative elevation differences of the opposing lateral deposit trim lines at bends of the stream thalweg. The extremely high velocity of the rock avalanche front caused the debris to surge up and overtop both ridgelines; the west ridge trim line has a differential rise of a minimum 206 ft (63 m), compared to the inside-curve trimline elevation on the opposing east side.

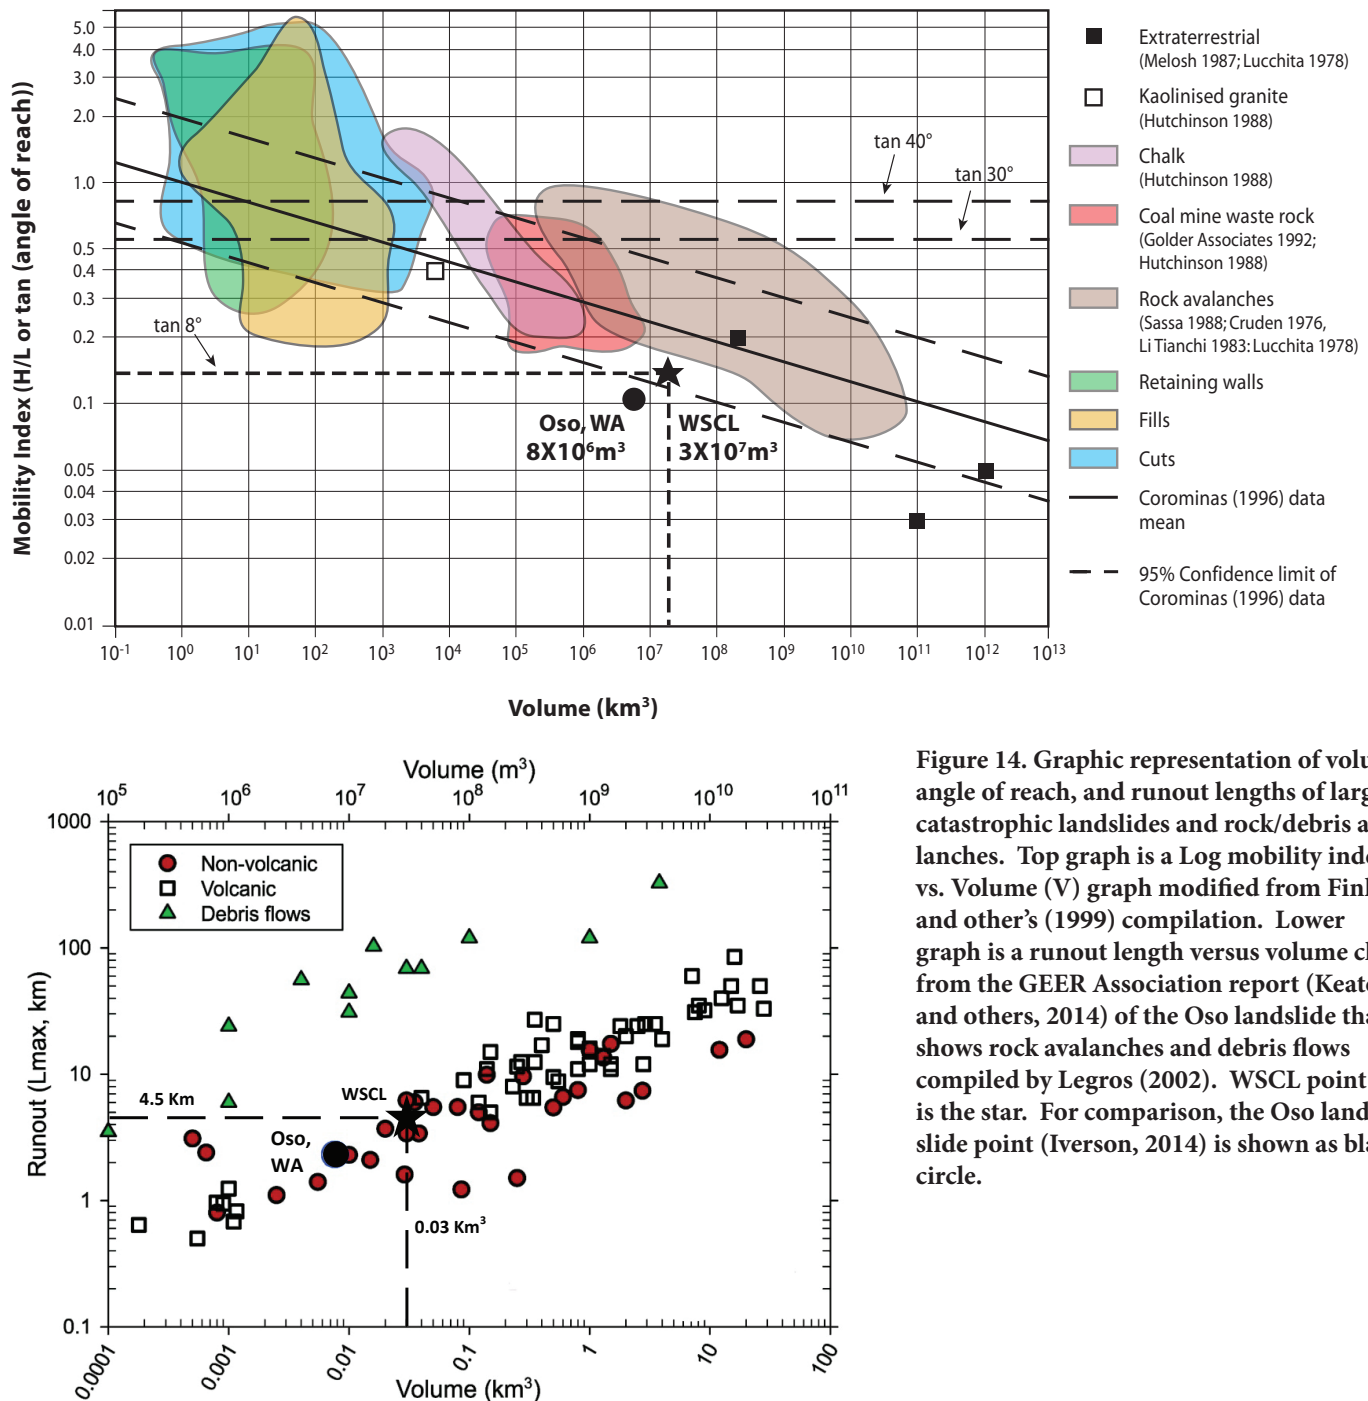
Figure 14. Graphic representation of volume, angle of reach, and runout lengths of large catastrophic landslides and rock/debris avalanches. Top graph is a Log mobility index vs. Volume (V) graph modified from Finlay and other's (1999) compilation. Lower graph is a runout length versus volume chart from the GEER Association report (Keaton and others, 2014) of the Oso landslide that shows rock avalanches and debris flows compiled by Legros (2002). WSCL point is the star. For comparison, the Oso landslide point (Iverson, 2014) is shown as black circle.

and other's (1999) compilation. The second lower graph of Figure 14 contains a compilation of data from Legros (2002) that shows the relationship between volume and runout length. This graph does not take into account landslide height and the WSCL plots within the general trend of rock avalanches. Also included in Figure 14 is a comparison point from the March 22, 2014 Oso landslide that caused 43 fatalities. This smaller but extremely rapid, high mobility, catastrophic mud and debris flow occurred in Washington State (Iverson and George, 2014; Keaton and others, 2014).

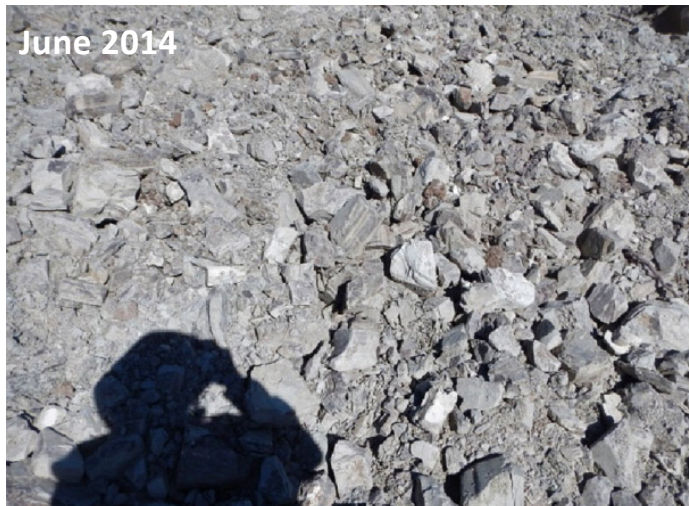
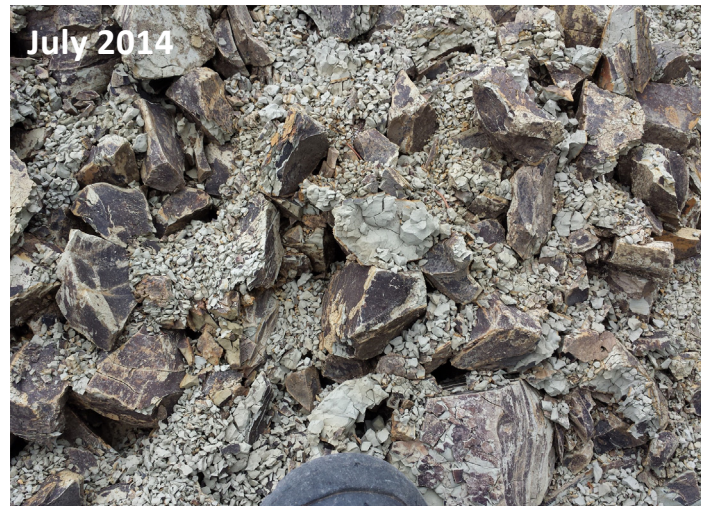
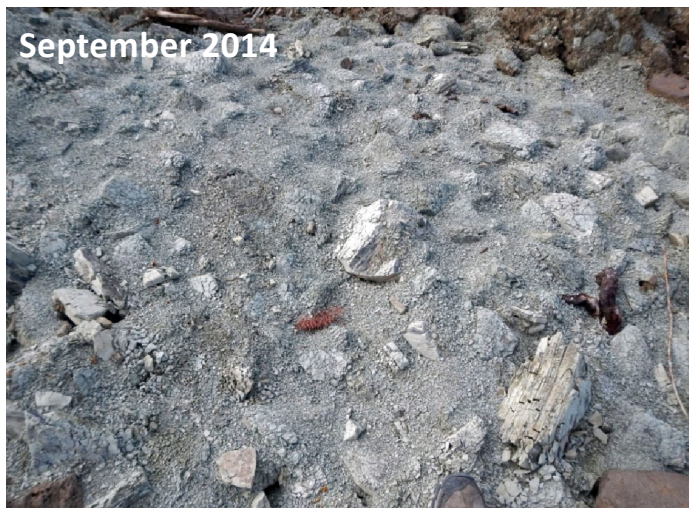
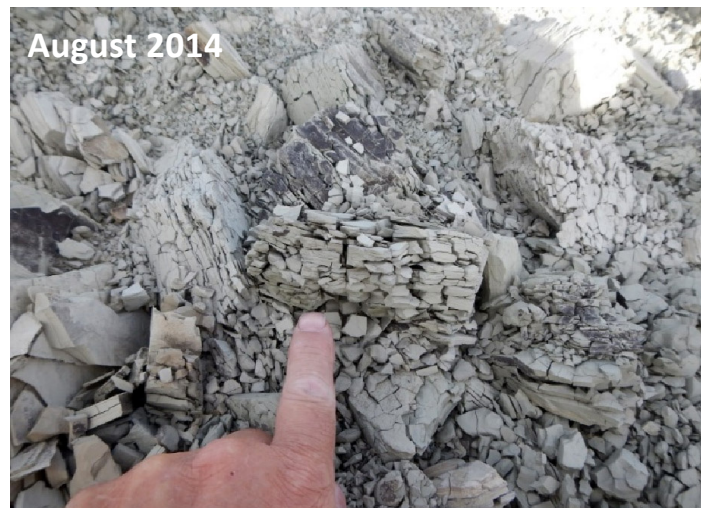
Figure 16. Rapid slaking of Green River Formation claystone and marlstone clasts in the WSCL debris field. Note surface staining of clasts and progression, clockwise from upper left, of rock disintegration in less than 4 months.

During the summer and fall of 2014, CGS observed that clasts of the Green River Formation, which comprise almost all of the landslide deposit, are highly susceptible to slaking when exposed to physical weathering. The clasts on the surface of the debris field rapidly disintegrated into finer and finer material (**Figure 16**) that will be easier for future debris flows to entrain and may increase their bulking factor.

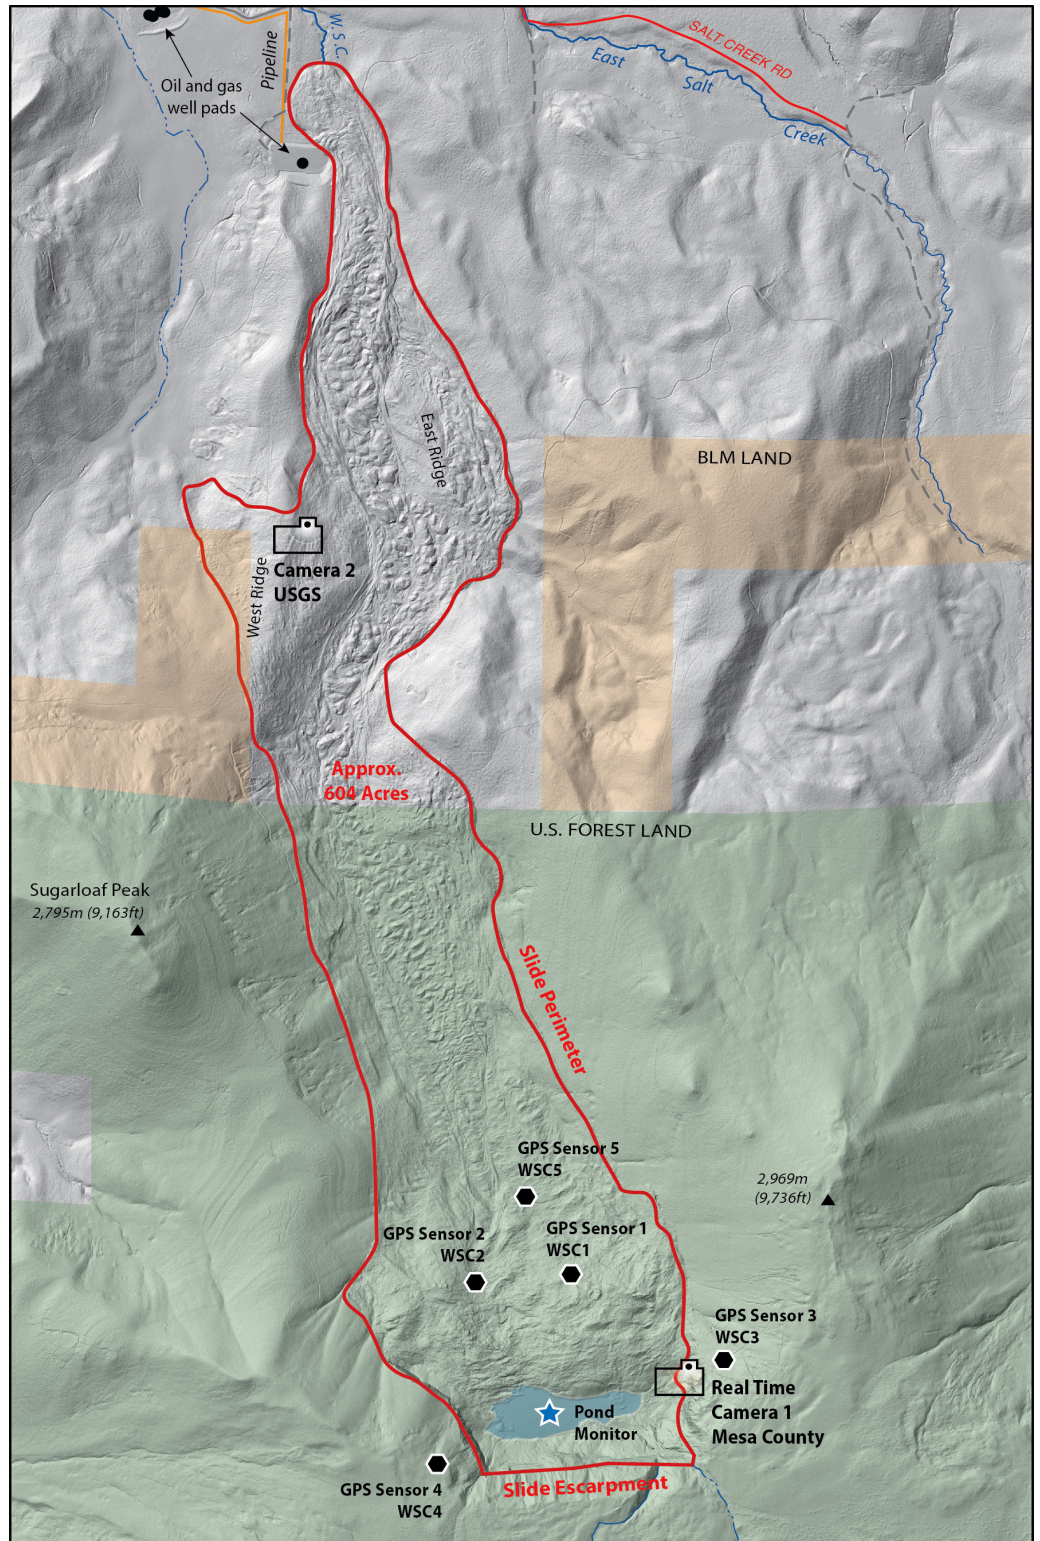
Figure 19. WSCL instrumentation and property ownership map. Map courtesy of the Mesa County GIS/IT Department.

Initial monitoring of the landslide included water level gages of the sag pond and the floor of West Salt Creek 750 ft (228 m) below the landslide toe, 5 GPS stations, and 2 web-based cameras. The locations of these tools are shown in **Figure 19** which also shows property ownership in the WSCL area. Following peak runoff (late June 2014) the pond level remained relatively consistent, indicating the lower summer inflow rate into the sag pond was about the same as the infiltration rate of water percolating into the landslide mass and rock avalanche debris field. During spring 2015, sag-pond levels rapidly rose 13 ft (4 m) before slowly dropping in mid June.

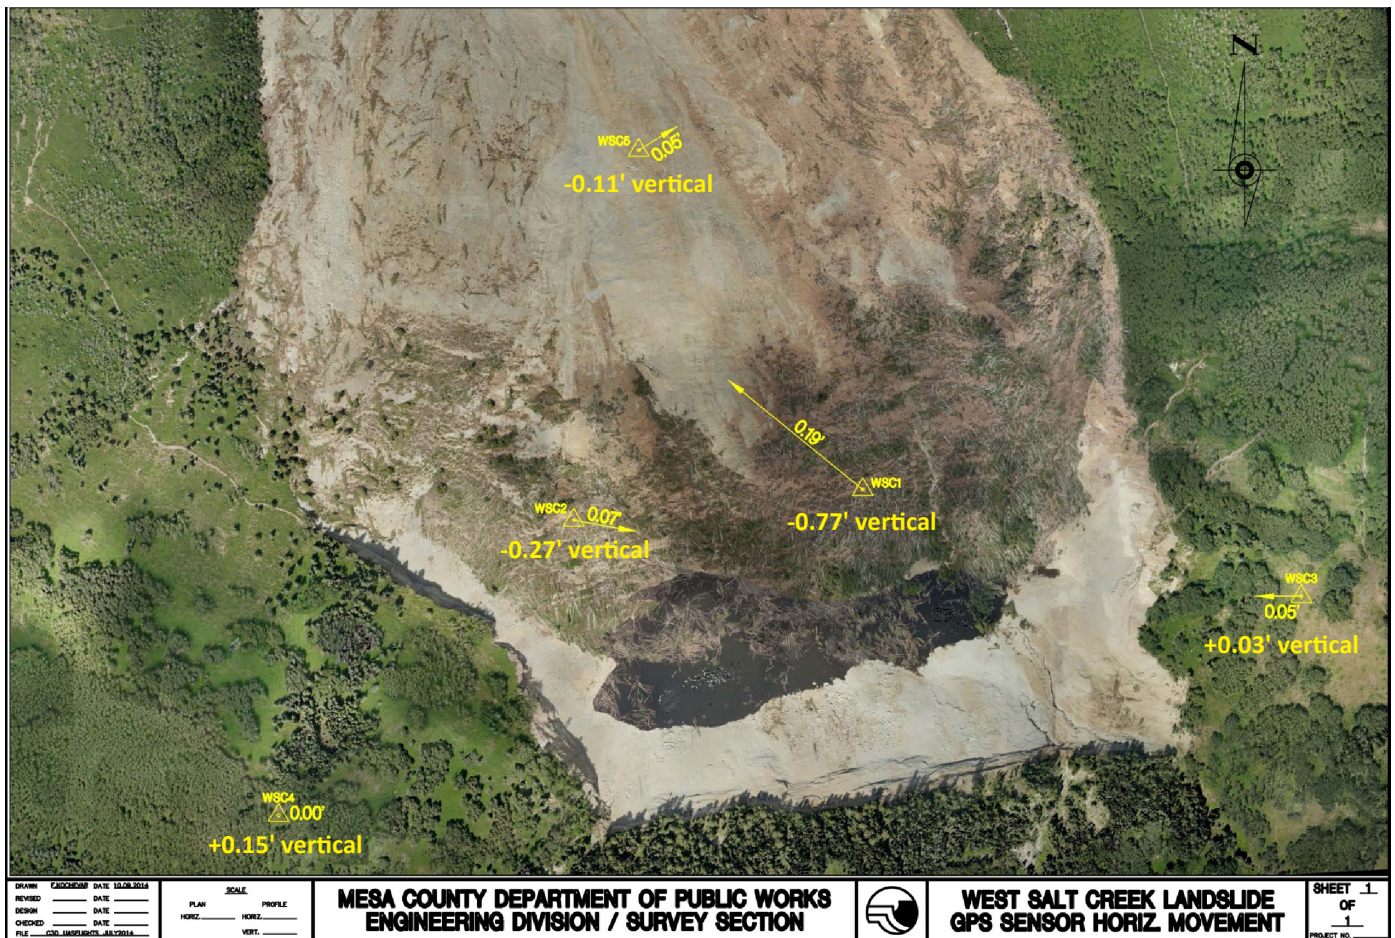
Figure 20. GPS sensor locations with horizontal vectors through October 1, 2014. Vertical displacements are also shown in yellow text. Lengths are in feet. Image courtesy of Frank Kochevar, Mesa County.

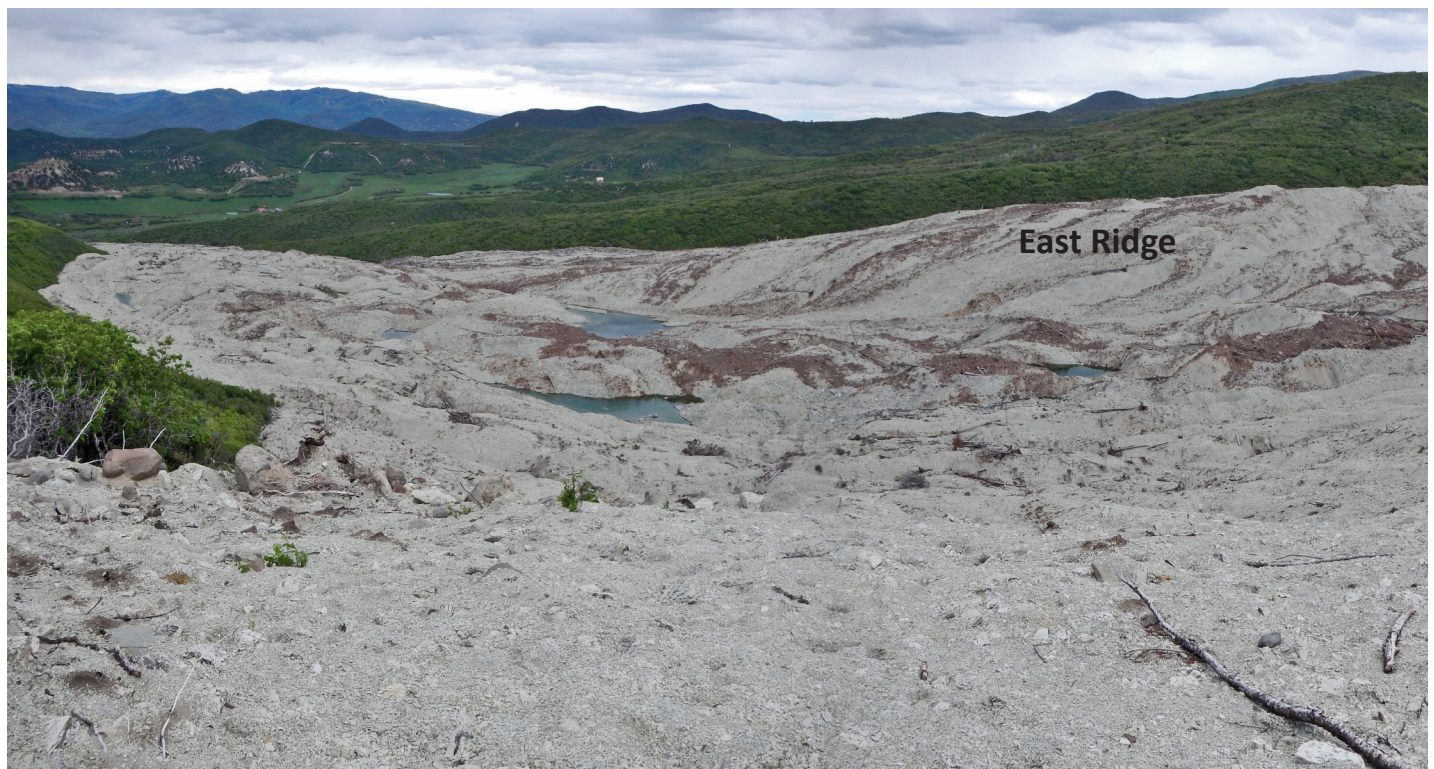
Figure 21. A year after the WSCL, large ponds formed on the hummocky late-surge rock/debris avalanche deposits. View is to the northeast from the West Ridge at the same location of Figure 11g. Note finer-grained debris field in foreground compared to Figure 11(g), as a result of year-long slaking of Green River Formation clasts. Photo date: June 5, 2015. Photo location is shown on Figure 9 map.

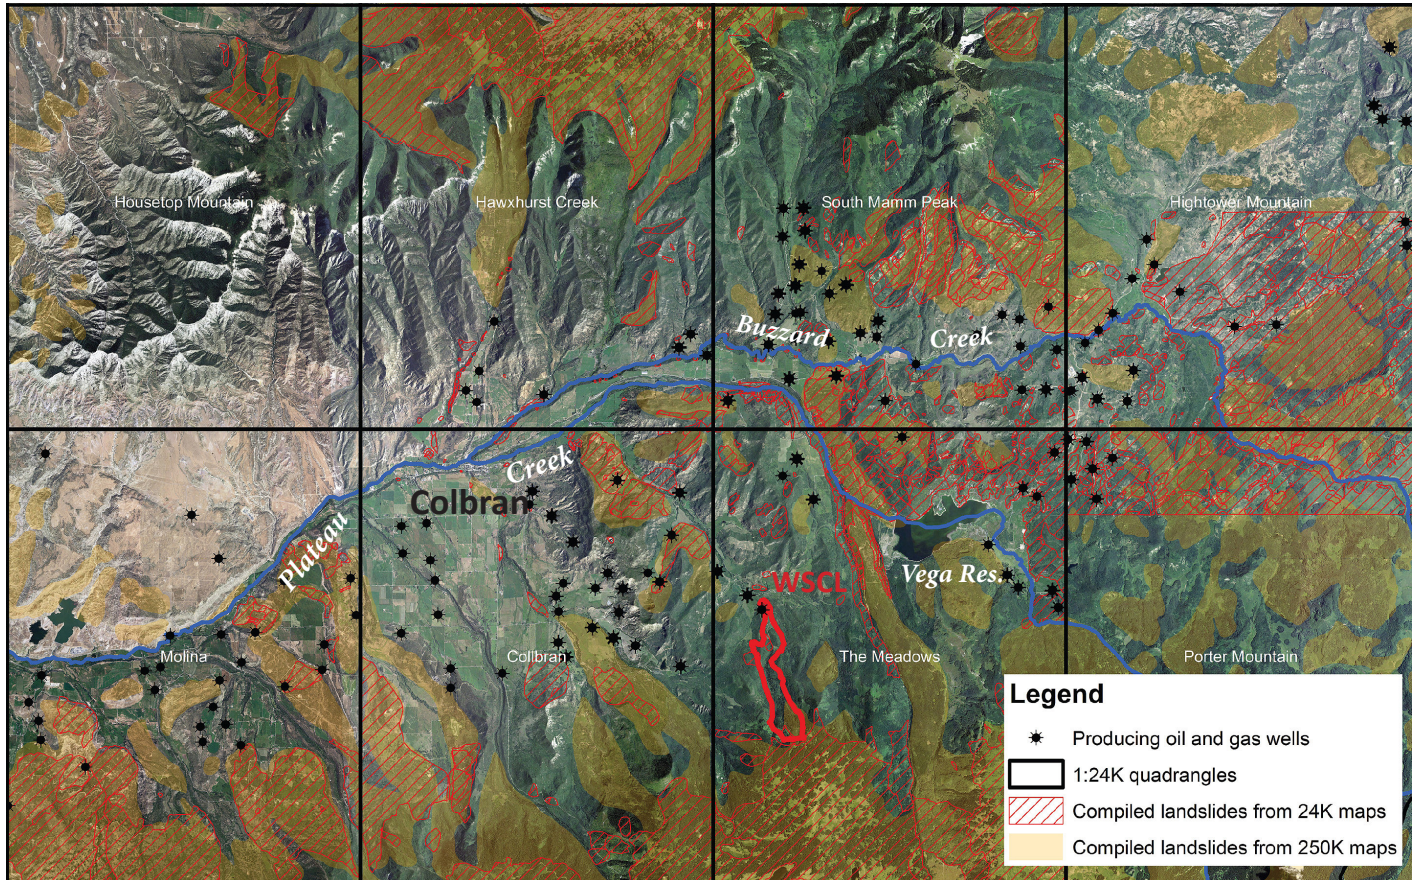
Figure 24. . Map of greater Plateau Creek basin showing location of oil and gas well pads and landslide inventory. The WSCL boundary is shown by solid red line. Basemap is a NAIP 2009 orthorectified aerial photograph. Note lack of mapped landslides near the WSCL in inventory compared to landslides mapped from LiDAR data on geologic map.
