# **ROADS AND CONNECTIVITY IN COLORADO: ANIMAL-VEHICLE COLLISIONS, WILDLIFE MITIGATION STRUCTURES, AND LYNX-ROADWAY INTERACTIONS**

**March 2008**

**COLORADO DEPARTMENT OF TRANSPORTATION  
RESEARCH BRANCH**

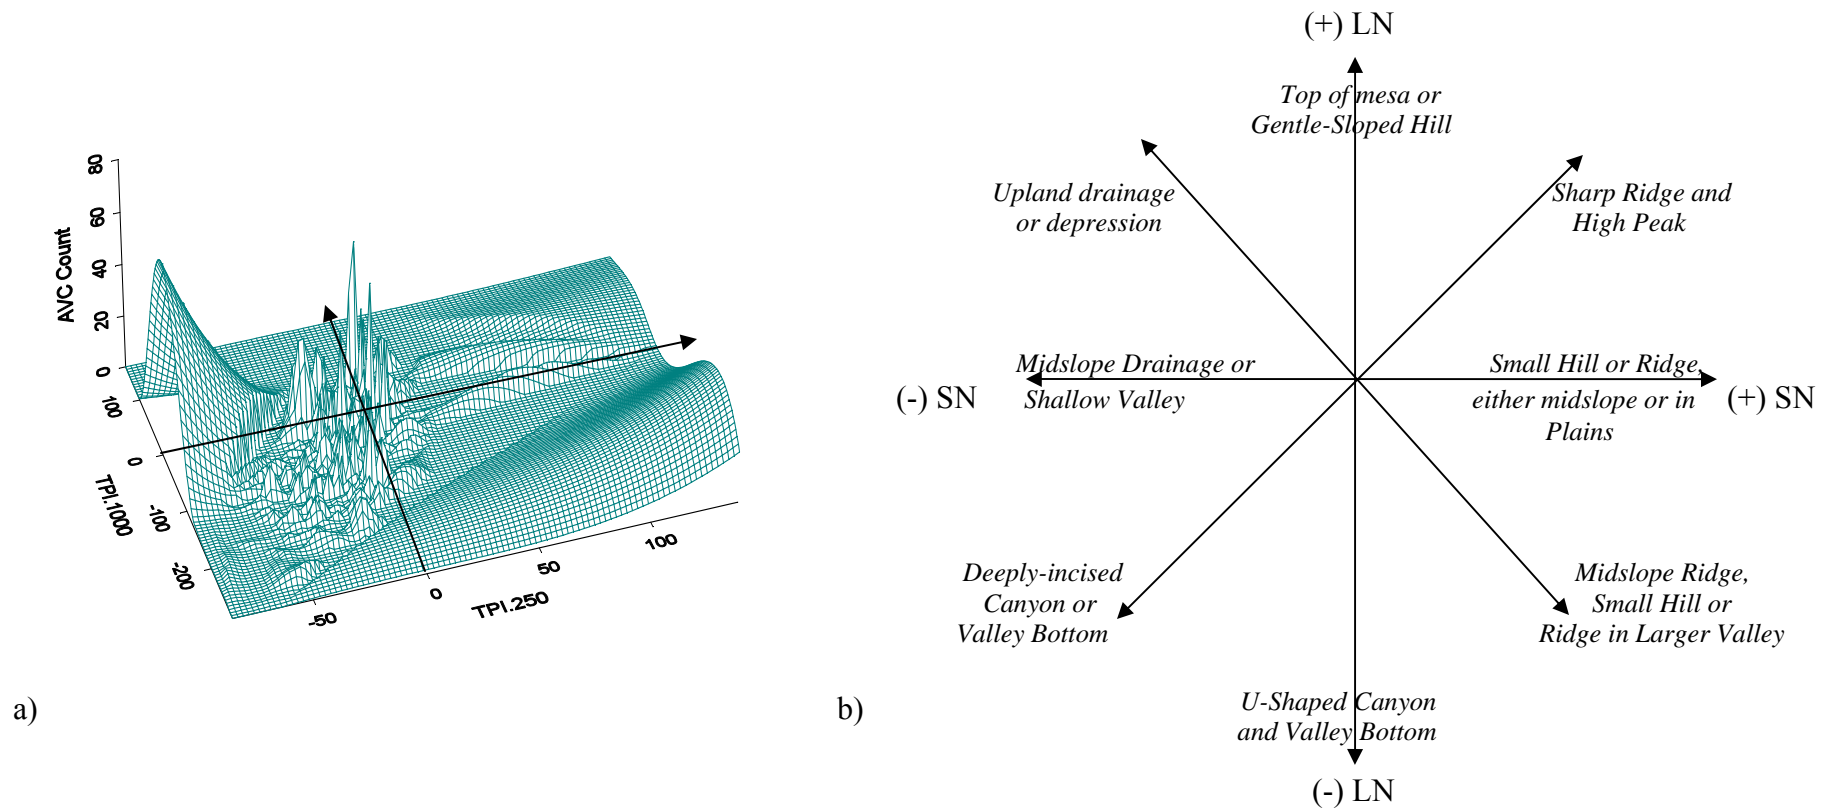
**Figure 12. a) a 3D representation of the relationship between AVCs resulting in property damage in Colorado from 1986-2004 (AVC count), and small- (250 m) and large-neighborhood (1000 m) Topographic Position Index (TPI); b) a reference classification scheme (adopted from Jenness 2006) as combination of positive and negative small- and large-scale neighborhood TPI can indicate the topographic type where AVCs are occurring. Large neighborhood (LN) values are represented by the TPI 1000 scale and small neighborhood (SN) values are represented by the TPI 250 scales.**

We used in this study TPI as an index for the topographic characteristics of areas near roads and used Jenness (2006) classification scheme. For both FAT and INJ and PDO analyses, high AVC counts occurred mostly near upland and midslope drainages (Figures 10 and 12). In addition, the mean distance to streams was smaller for areas near top 1% AVC counts as compared to the study site availability (Tables 4 and 5). Both variables may represent areas that are conducive to animal movements along riparian corridors, and suggest that these areas are more likely to have a high degree of AVCs.

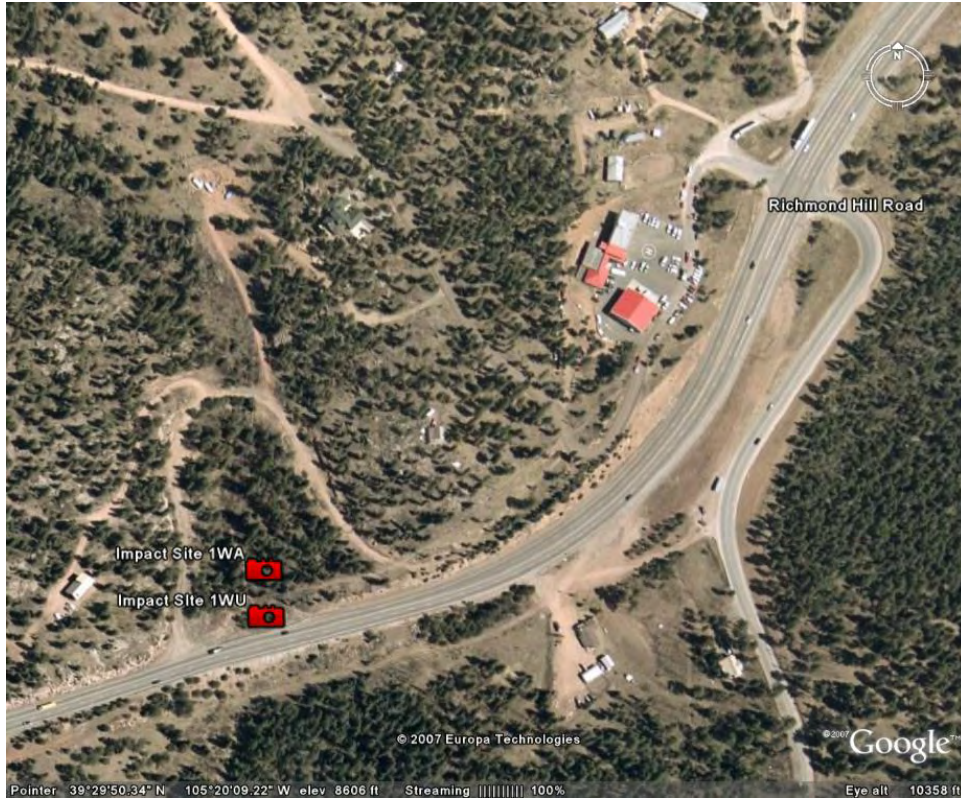
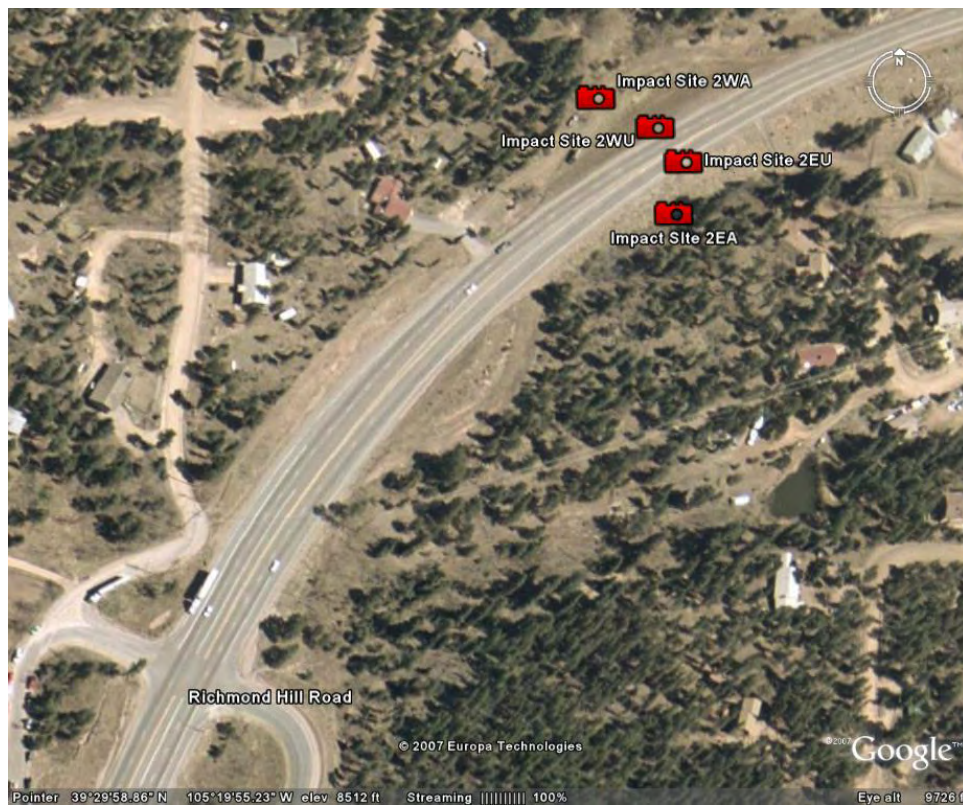
a) Impact site overview and transects (no transect at Impact Site 3)

**Figure 15. Aerial images of U.S. 285 Conifer-Bailey a) impact site and b) control site, including a site overview and transect close-up. Station labels include: west approach (WA), west underpass (WU), east underpass (EU), and east approach (EA).**

Figures 15 (aerial image) and 16 (schematic diagram) show the locations of the impact site monitoring stations. Figure 15 provides detail of the positioning of the camera stations relative to the surrounding habitat, and GPS coordinates of each station are provided in Appendix B.1. Impact Site 1 had two cameras (one roadside camera and one approach camera) on the western side of the highway. Cameras were not placed on the eastern side of the highway due to ongoing construction activities (see *Monitoring Schedule* section below). Impact Site 2 consisted of four camera stations placed along a transect perpendicular to the highway. Two of these cameras were located at approaches on both the east and west side of the highway and two cameras were placed at opposing entrances to a small 2 ft diameter metal pipe culvert. The location of this culvert was planned for the Green Valley Grill underpass designed to provide movement for a variety of larger-bodied wildlife species, particularly elk and mule deer. This underpass was constructed during the course of this study. Impact Site 3 consisted of a single camera located at the western approach to the highway at MP 234.4. Representative site photos are shown in Appendix B.2.

Figures 15 (aerial images) and 16 (schematic diagram) show the locations of the impact site monitoring stations. Figure 15 provides detail of the positioning of the camera stations relative to the surrounding habitat, and GPS coordinates of each station are provided in Appendix B.1. Control Site 1 consisted of four camera stations placed along a transect perpendicular to the highway. Two of these cameras were located at approaches on both the east and west side of the highway and two cameras were placed at opposing entrances to the Deer Creek bridge. Control Site 2 also consisted of four camera stations placed along a transect perpendicular to the highway. Two of these cameras were located at approaches on both the east and west side of the highway and two cameras were placed at opposing entrances to the 8 ft diameter metal pipe culvert. Although these two structures were not be redesigned during the current phase of construction in the impact site, they are slated for improvement during future phases of the U.S. 285 highway improvement project between Conifer and Bailey. While the dimensions of the proposed Deer Creek bridge structure have not been presented, the Roland Gulch culvert will be replaced by a bridge approximately 600 ft in width and approximately 30-40 ft in height. Although it is unknown as to when this phase of highway construction will begin, monitoring these sites will provide valuable baseline data as to the rate of wildlife movement through and surrounding the existing underpass locations. Representative site photos are shown in Appendix B.2.

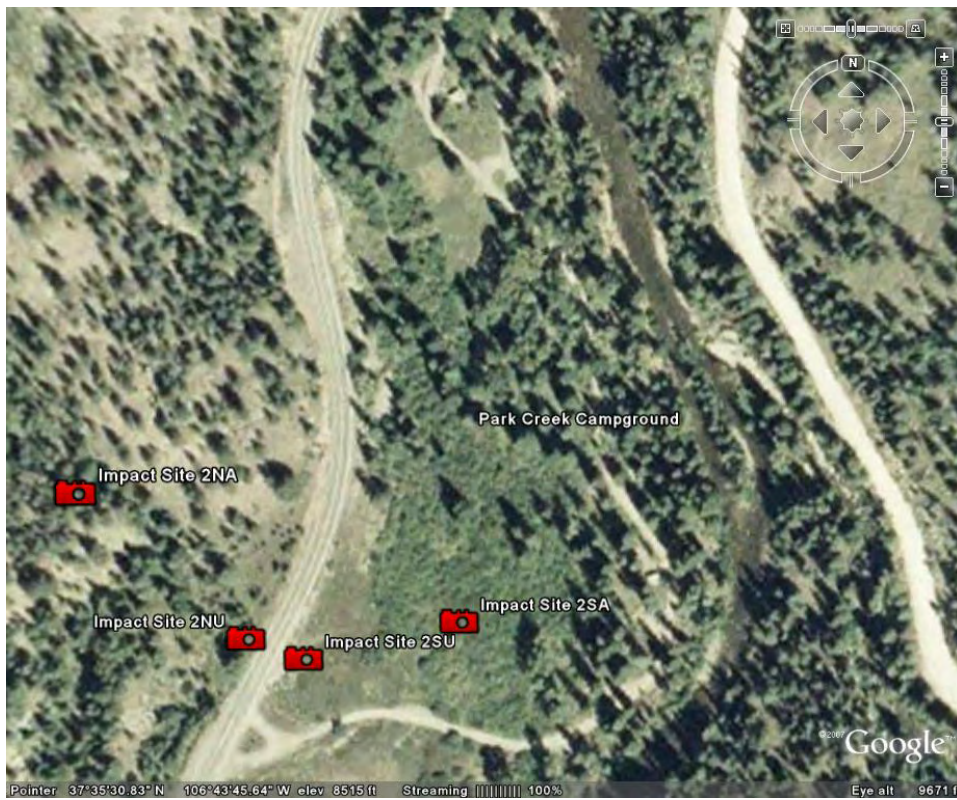
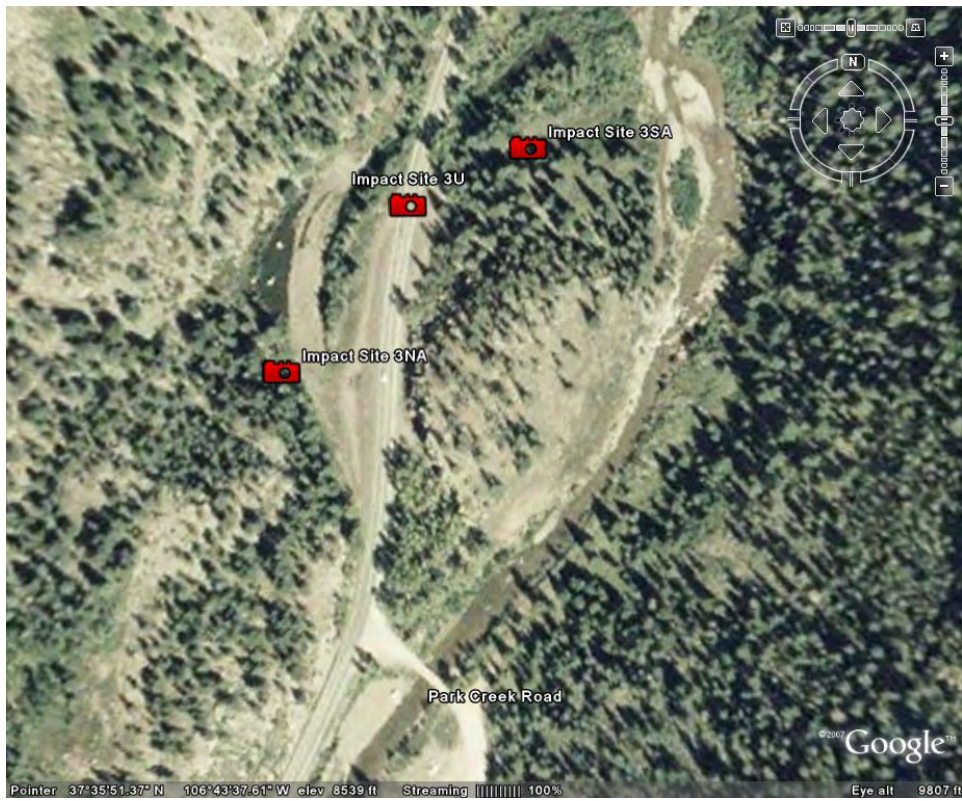
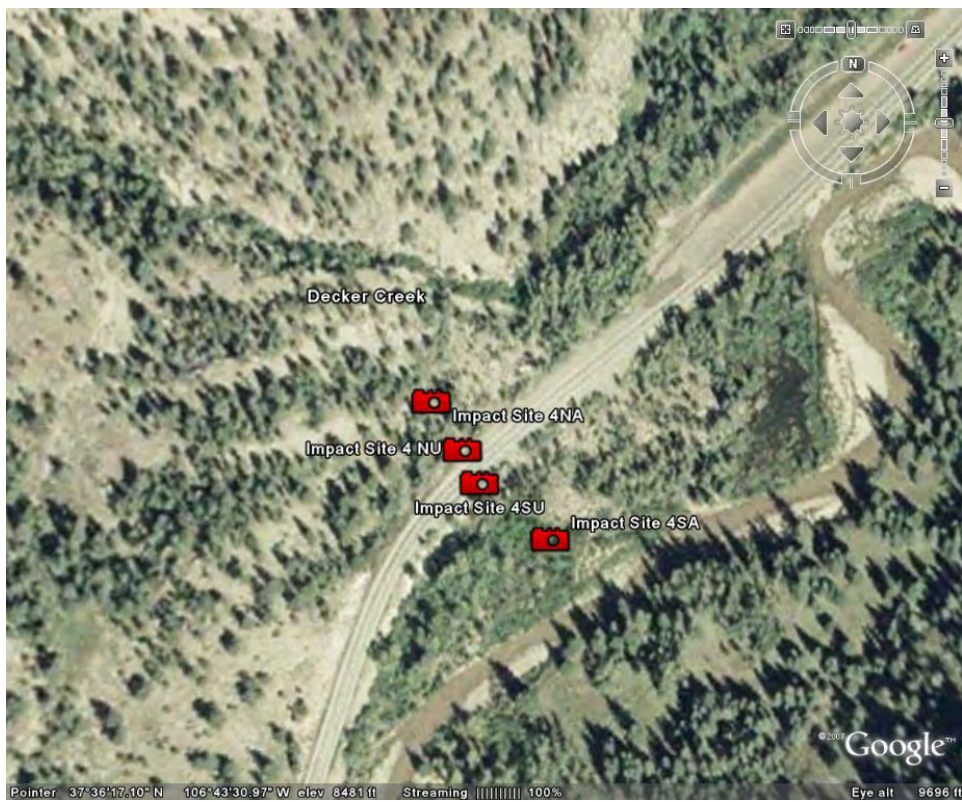
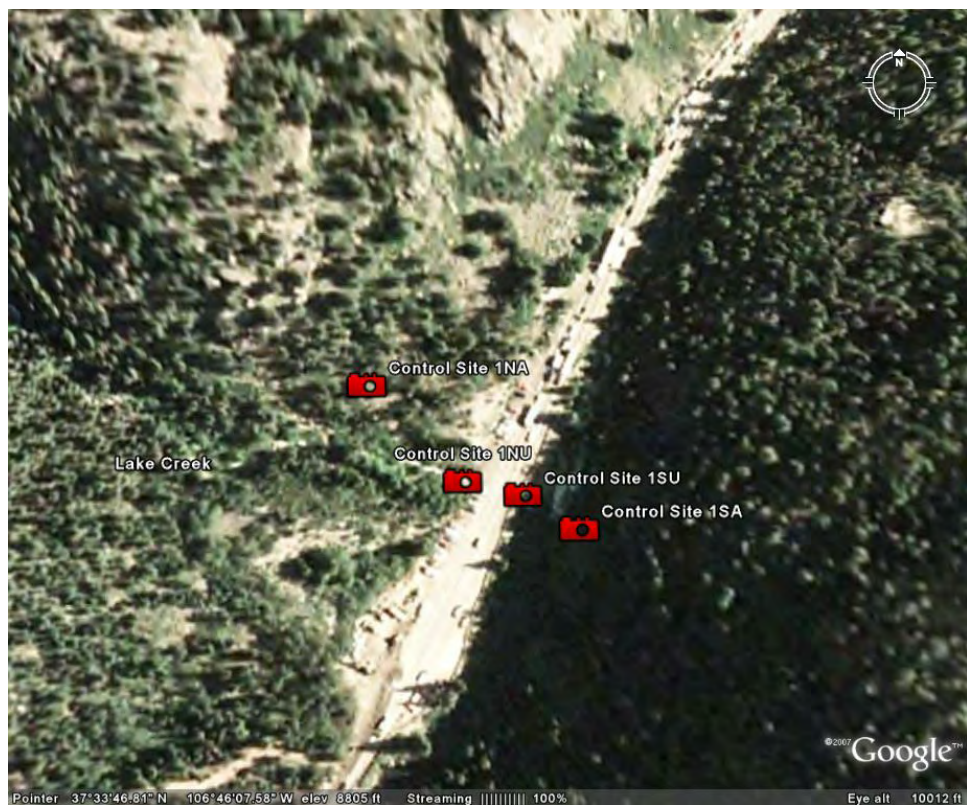
a) Impact site overview and transects (no transect at Impact Site 1)

b) Control site overview and transects, including Impact Site 5

**Figure 18. Aerial image of U.S. 160 Wolf Creek Pass a) impact site and b) control site, including a site overview and transect close-up. Station labels include: north approach (NA), north underpass (NU), south underpass (SU), and south approach (SA).**

Figures 18 (aerial images) and 19 (schematic diagram) show the locations of the impact site monitoring stations. Figure 18 provides detail of the positioning of the camera stations relative to the surrounding habitat, and GPS coordinates of each station are provided in Appendix B.3. Impact Site 1 had one camera positioned along a powerline corridor on the western side of the highway.

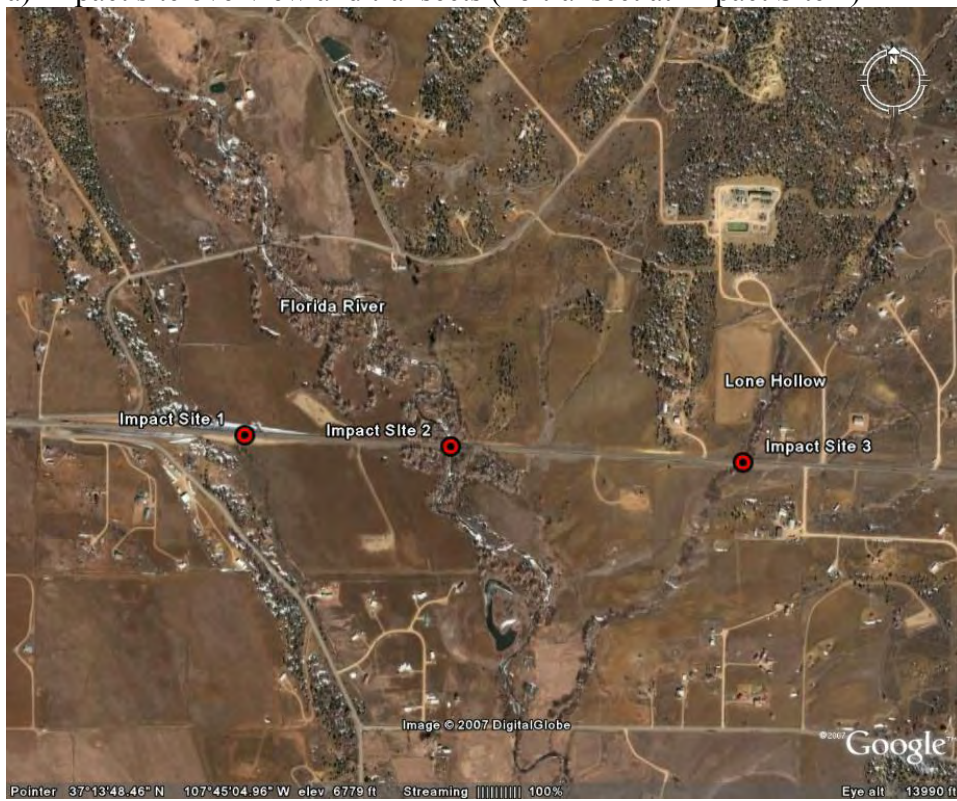
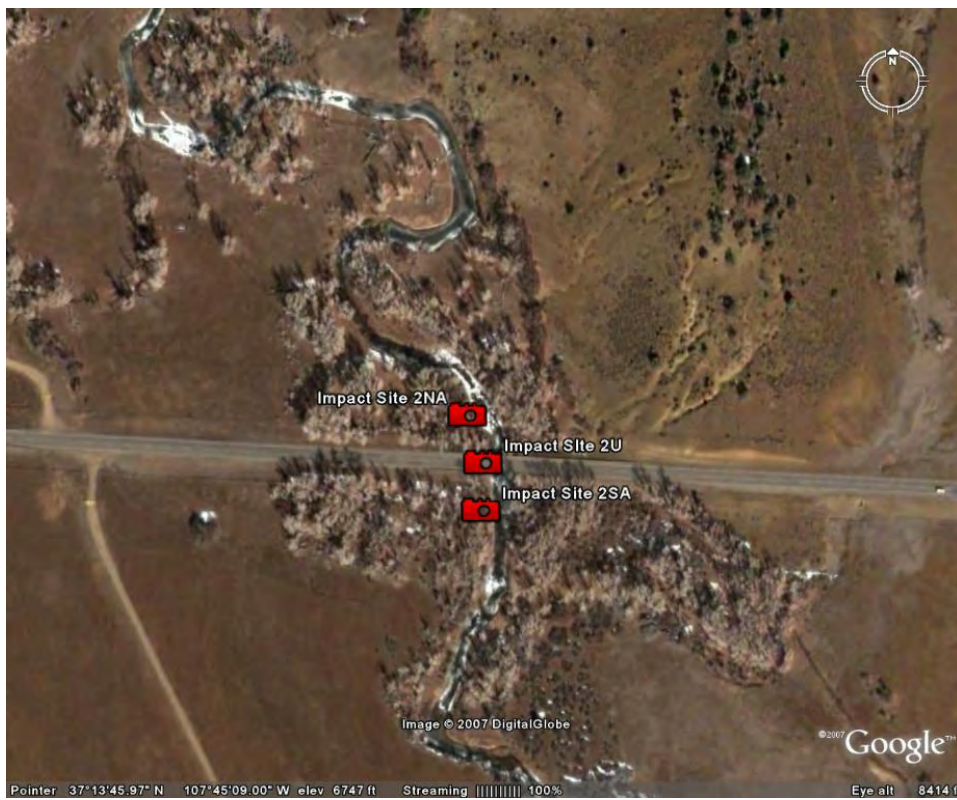
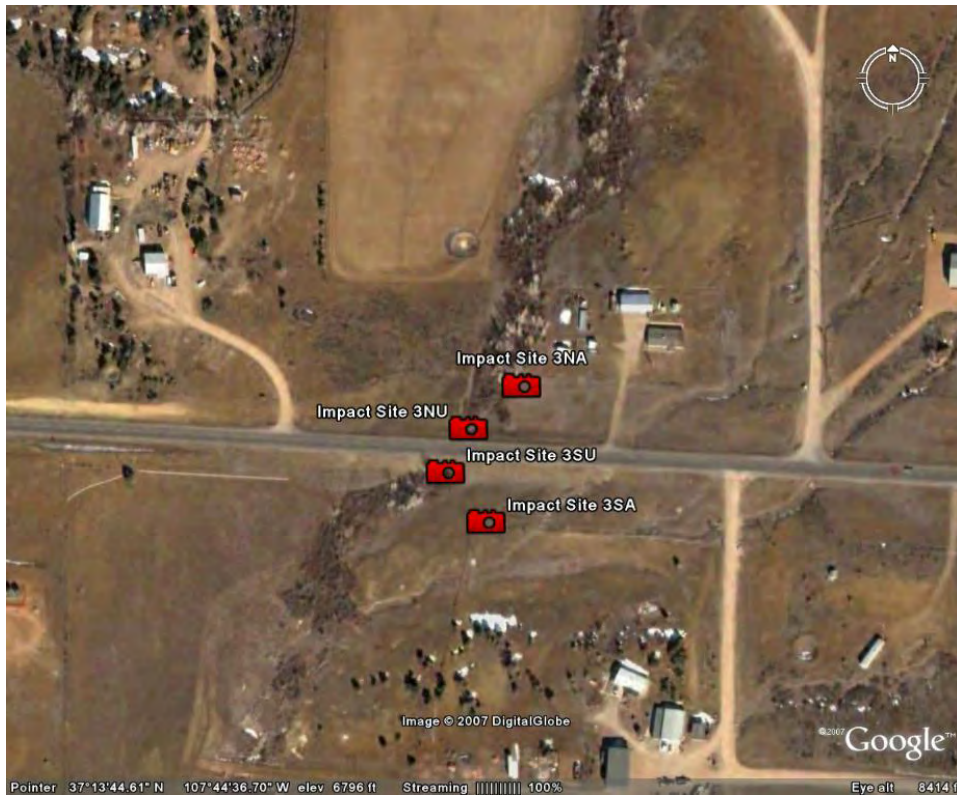
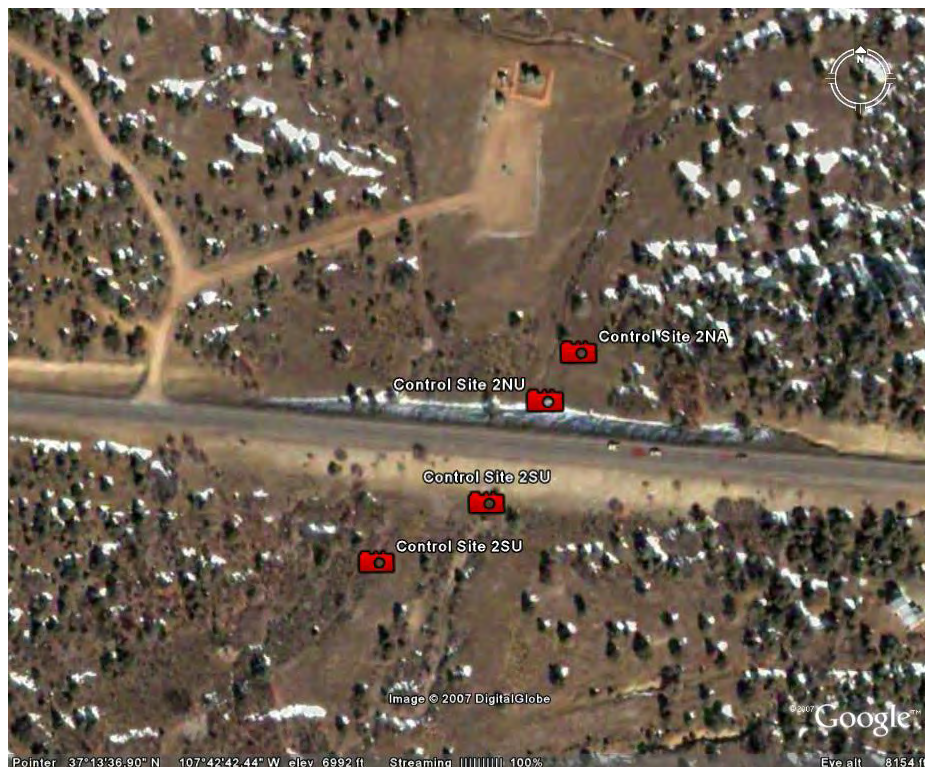
a) Impact site overview and transects (no transect at Impact Site 1)

b) Control Site overview and transects

**Figure 22. Aerial image of U.S. 160 Durango-Bayfield a) impact site and b) control site, including a site overview and transect close-up. Station labels include: north approach (NA), north underpass (NU), south underpass (SU), and south approach (SA).**

Figures 22 (aerial images) and 23 (schematic diagram) show the locations of the impact site monitoring stations. Figure 22 provides detail of the positioning of the camera stations relative to the surrounding habitat, and GPS coordinates of each station are provided in Appendix B.5. Impact Site 1 consisted of a single camera positioned at the base of a long fill

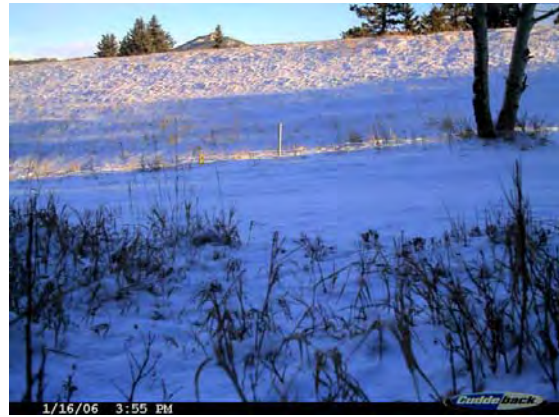
Impact Site 2: Green Valley Grill underpass before construction

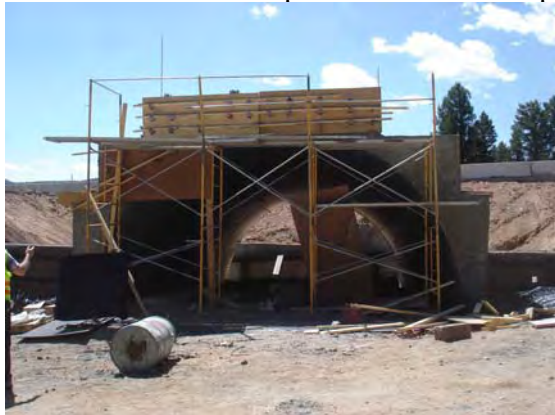
Impact Site 2 during construction of the southbound U.S. 285 portion of the underpass

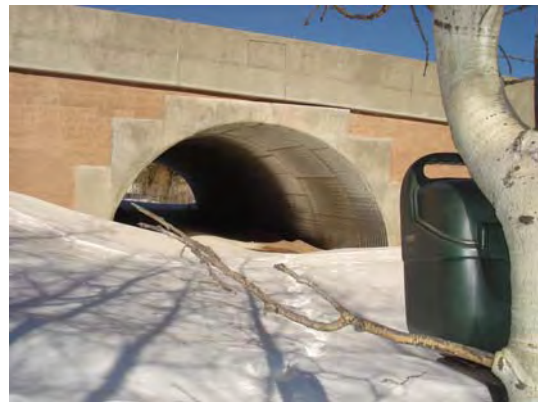
Impact Site 2 after construction

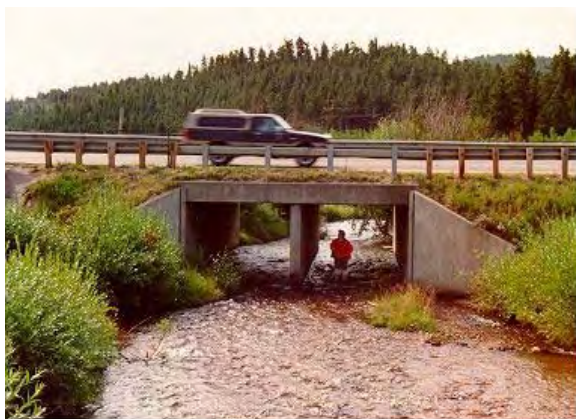
Control Site 1: Deer Creek span bridge<sup>1</sup>

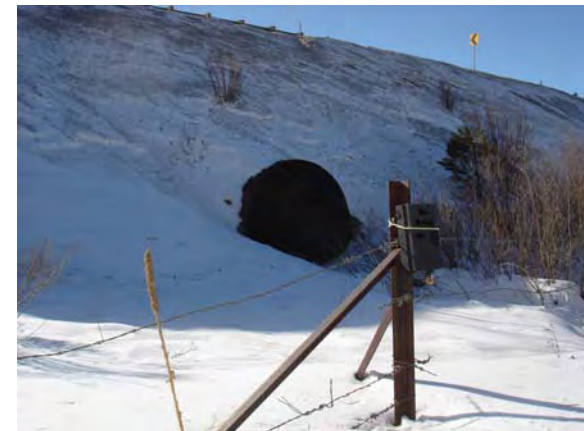
Control Site 2: Roland Gulch culvert, west entrance

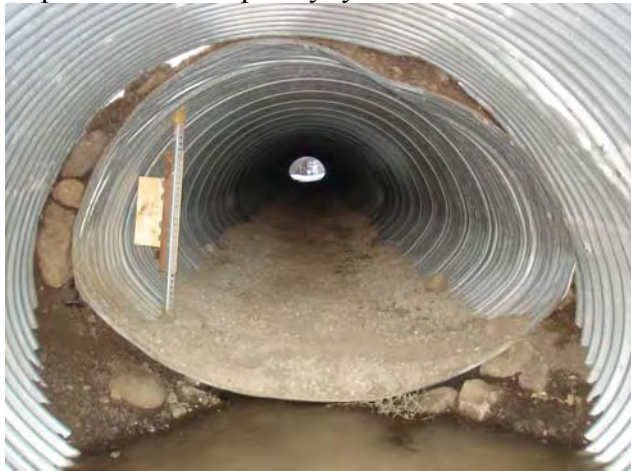
Impact Site 3: temporary lynx structure

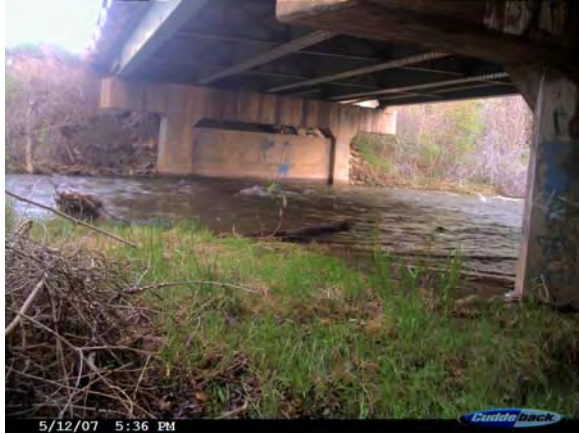
Impact Site 2: Florida River bridge

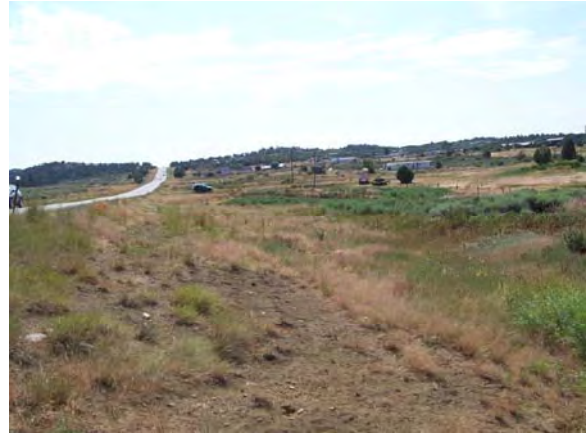
Impact Site 3: Long Hollow culvert<sup>2</sup>

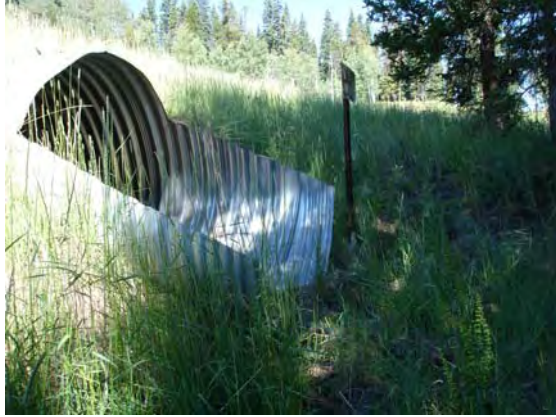
**Appendix C.3. Representative site photos and underpass conditions at the U.S. 40, Muddy Pass MP1 underpass.**

August 2005 (grass regeneration east side)

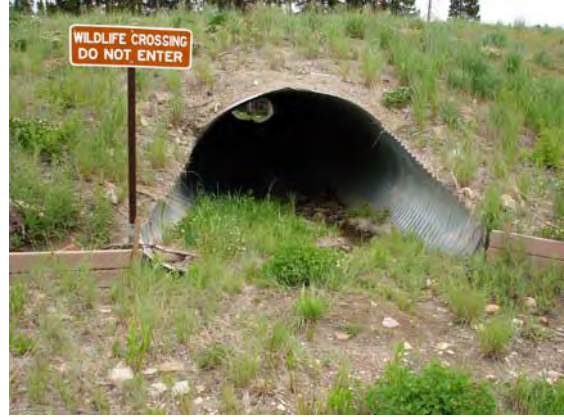
August 2006 (grass regeneration west side)

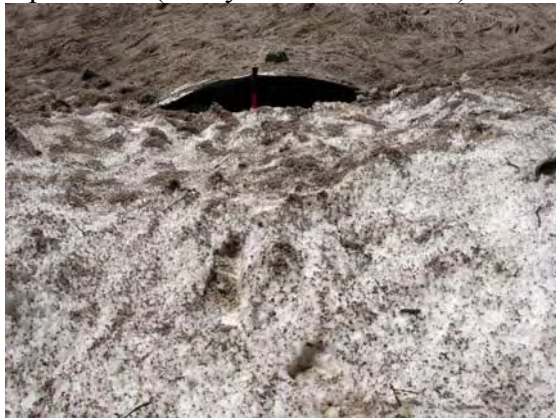
April 2006 (heavy snow conditions)

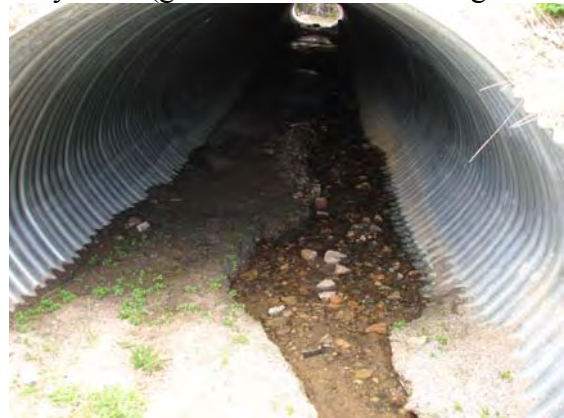
May 2006 (ground water flow through tunnel)

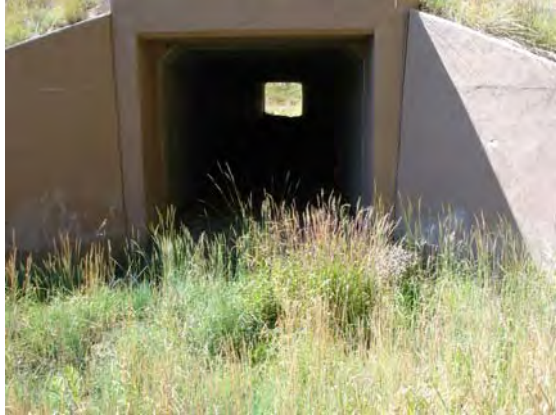
**Appendix C.5. Representative site photos and underpass conditions at the U.S. 40, Muddy Pass MP1 underpass.**

August 2006 (grass regeneration east side)

Representative site photos and underpass conditions are shown in Appendix C.5.

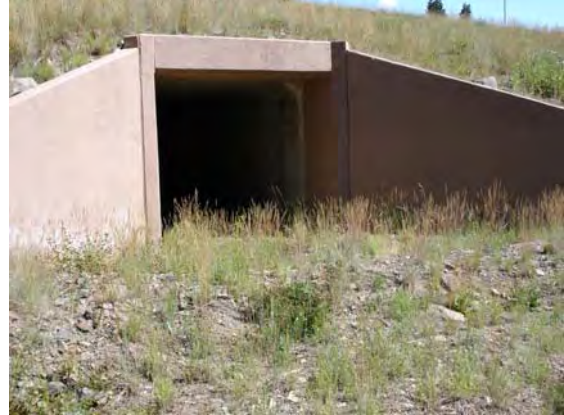
August 2006 (grass regeneration west side)

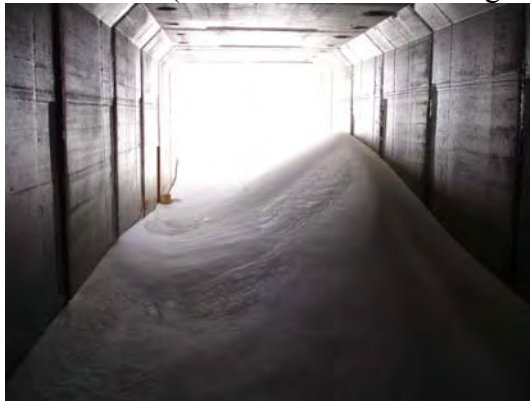
March 2006 (snow drift inside looking west)

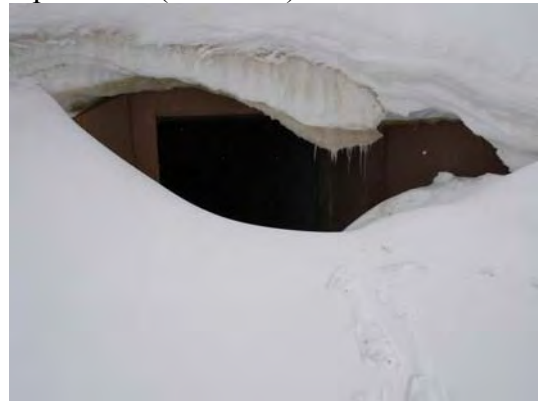
April 2006 (west side)

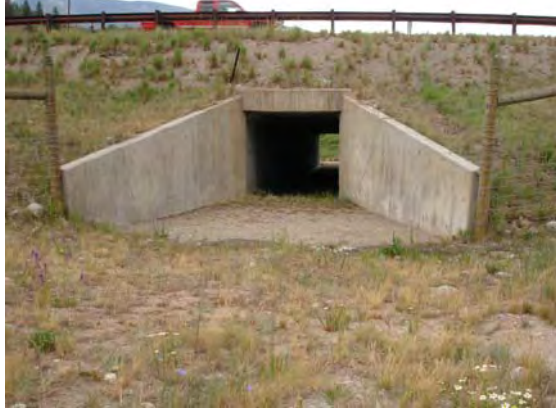
**Appendix C.7. Representative site photos and underpass conditions at the SH 9, Silverthorne S1 underpass.**

July 2006 (grass regeneration west side)

Representative site photos and underpass conditions are shown in Appendix C.7.

The local topography was well suited for wildlife movement on the west side of the underpass. The hills and gully that border the west side naturally channel wildlife towards the underpass. However, the east side of the underpass borders the Blue River, which may act as a barrier for smaller animals, especially during periods of high runoff. The height and width of the tunnel was suitable for all species of wildlife and the length of the tunnel was sufficiently short for light to penetrate and illuminate the interior of the underpass. During the winter and spring months the icy conditions and slight slope of the underpass made it difficult to walk through the tunnel to check the camera station. This may be a limiting factor for larger bodied animals using the tunnel. Snow conditions were mild compared to other underpasses. Constant solar radiation along the east side of the tunnel kept snow levels fairly low and the only deep snow occurred on the west side in the shade. Similar to the underpass at Muddy Pass (MP1), human use was noticeable. Anglers and hunters and other pedestrians used the underpass often. Graffiti was found inside the east entrance in the spring of 2007. There are no signs outside the tunnel notifying the public that the tunnel is for wildlife use only. Overall, S1 seemed to be one of the best tunnels suited for wildlife passage.

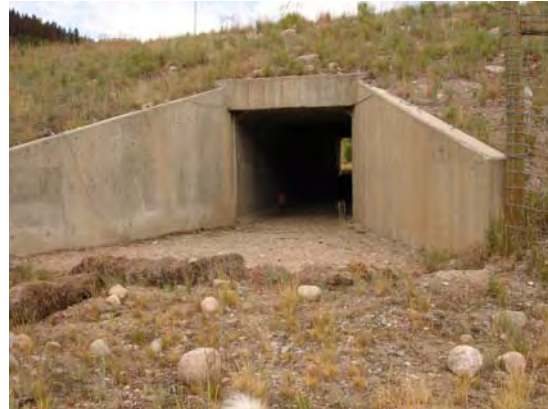
July 2006 (grass regeneration east side)

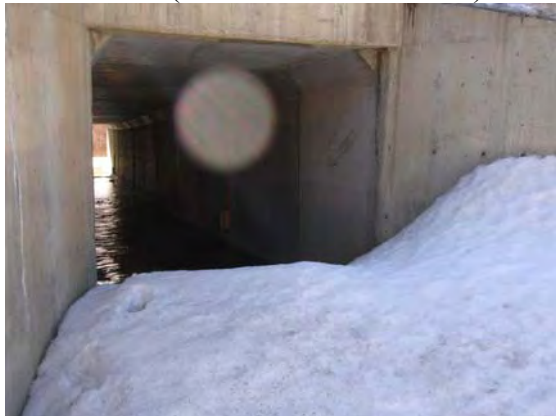
March 2007 (snow and ice west side)

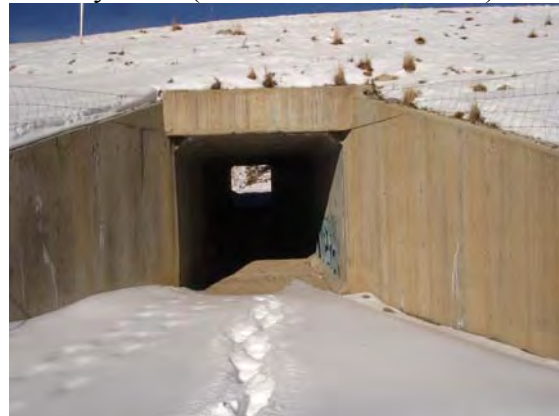
January 2007 (snow outside east side)

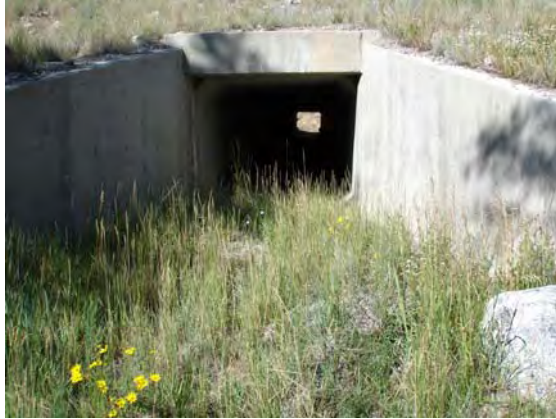
**Appendix C.9. Representative site photos and underpass conditions at the SH 9, Silverthorne S1 underpass.**

August 2006 (grass regeneration east side)

Representative site photos and underpass conditions are shown in Appendix C.9.

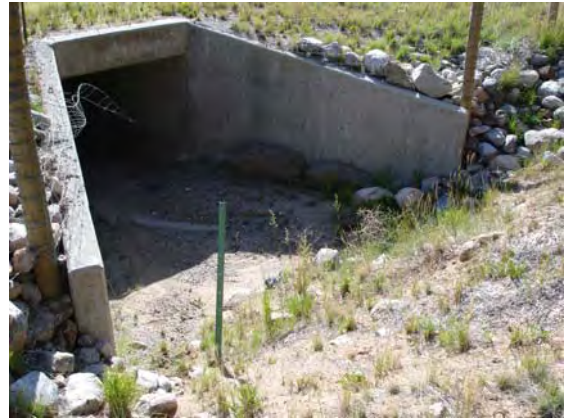
August 2006 (grass regeneration west side)

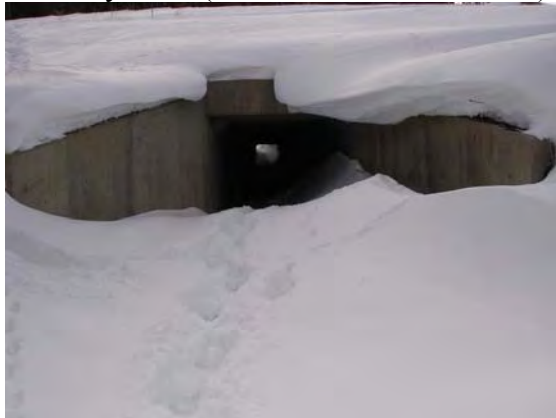
February 2006 (snow conditions east side)

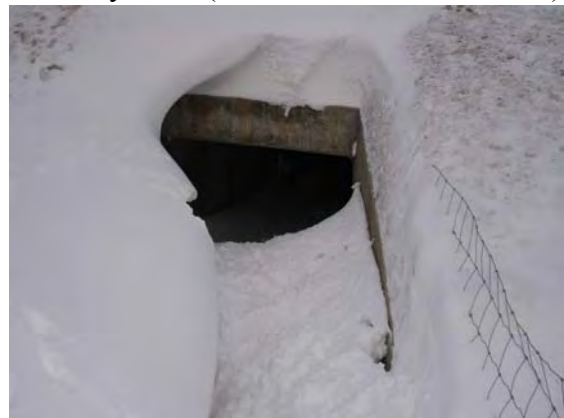
February 2006 (snow conditions west side)

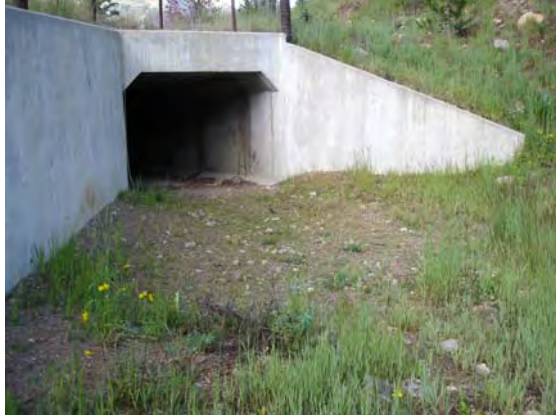
**Appendix C.10. Representative site photos and underpass conditions at the U.S. 40, Berthoud Pass BP1 underpass.**

August 2006 (grass regeneration north side)

- Late summer 2005: Mud inside tunnel no longer a problem
- Winter 2005 and 2006: Heavy drifting of snow inside north entrance, up to 30 ft inside tunnel
- Late spring 2006: Ice continues to build up over early spring months and lasts until late spring
- It is difficult to access the camera station on the north side due to the slope and ice conditions inside the tunnel which may also limit wildlife use
- Snow levels outside tunnel entrances ranged from 5ft to 6 ft in the winters of 2005 and 2006

Representative site photos and underpass conditions are shown in Appendix C.10.

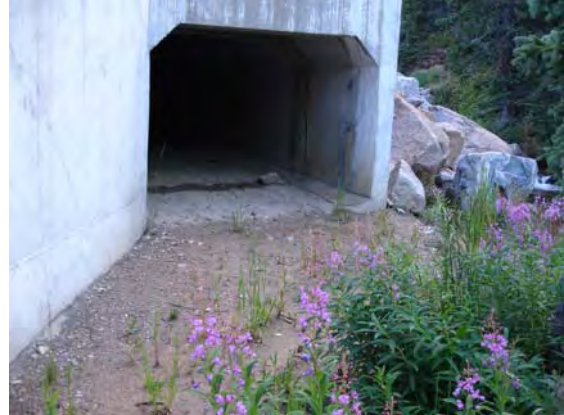
August 2006 (grass regeneration south side)

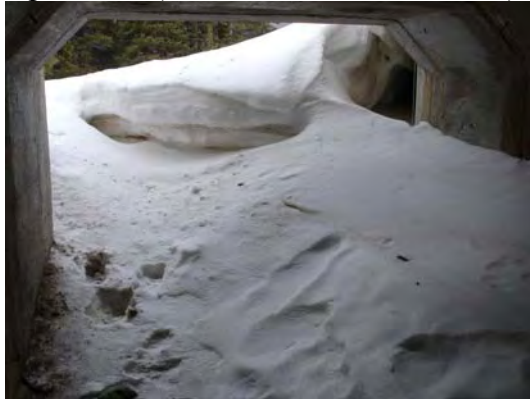
April 2006 (snow conditions north side)

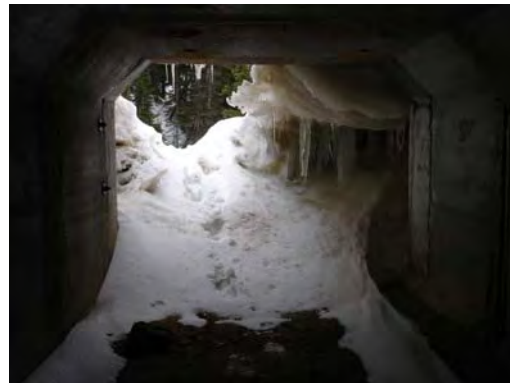
April 2006 (snow conditions south side)

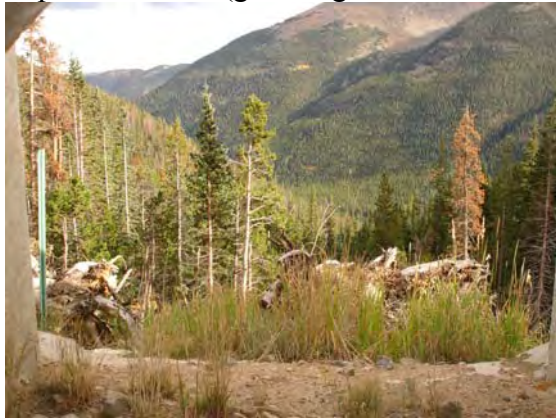
**Appendix C.11. Representative site photos and underpass conditions at the U.S. 40, Berthoud Pass BP2 underpass.**

September 2005 (grass regeneration south side)

Representative site photos and underpass conditions are shown in Appendix C.11.

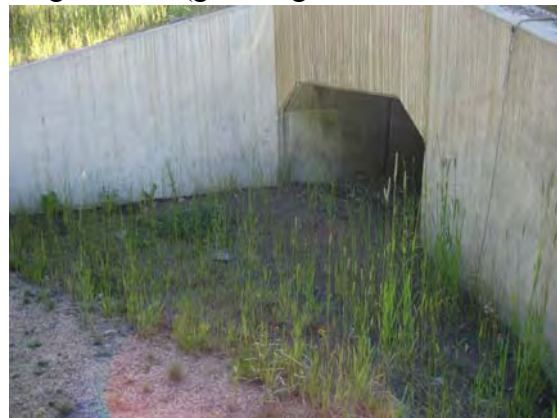
August 2006 (grass regeneration north side)

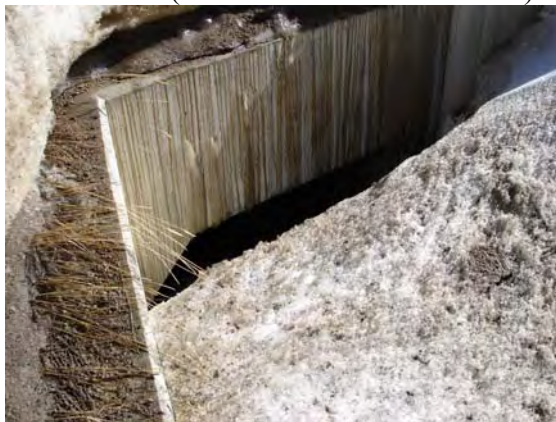
March 2006 (snow conditions north side)

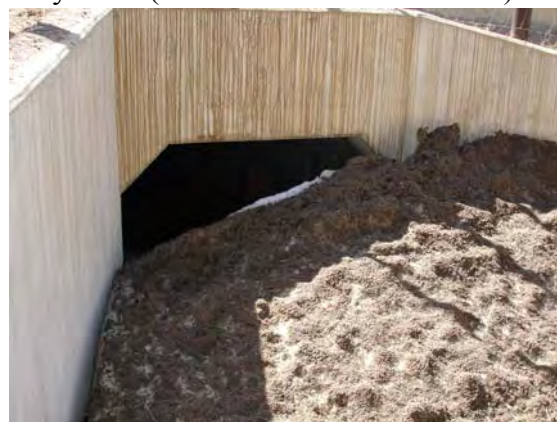
May 2007 (snow conditions north side)
